The pictures that follow in this show were taken on the 19th December 2010.

The coupes are in the Little Fisher and Fisher River area near the Dublin Plains.

Coupe CR154V

The second series are from an unknown operator Forest Practices Plan JRM0010.

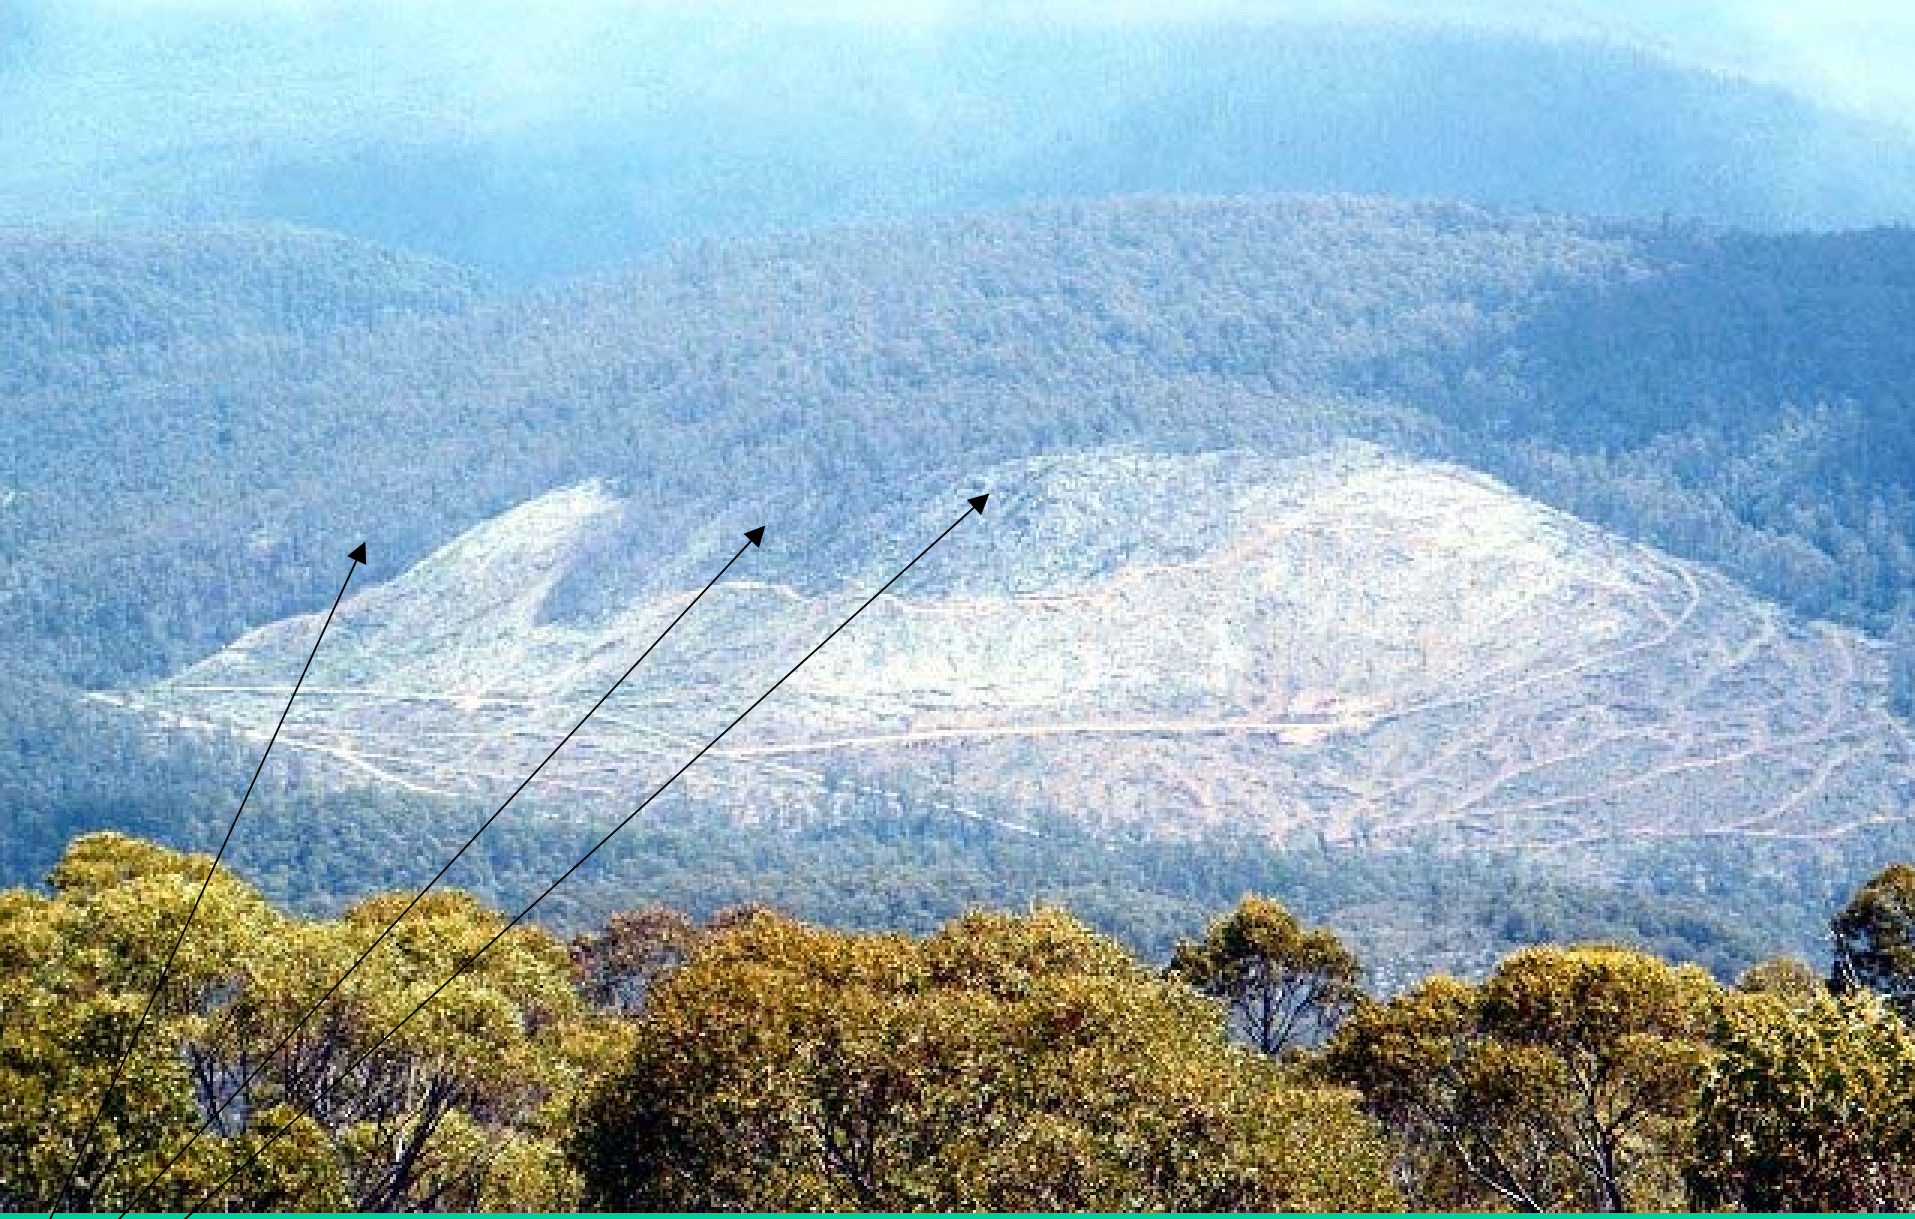
Coupe CR154V from a distance note the areas burnt outside the coupe

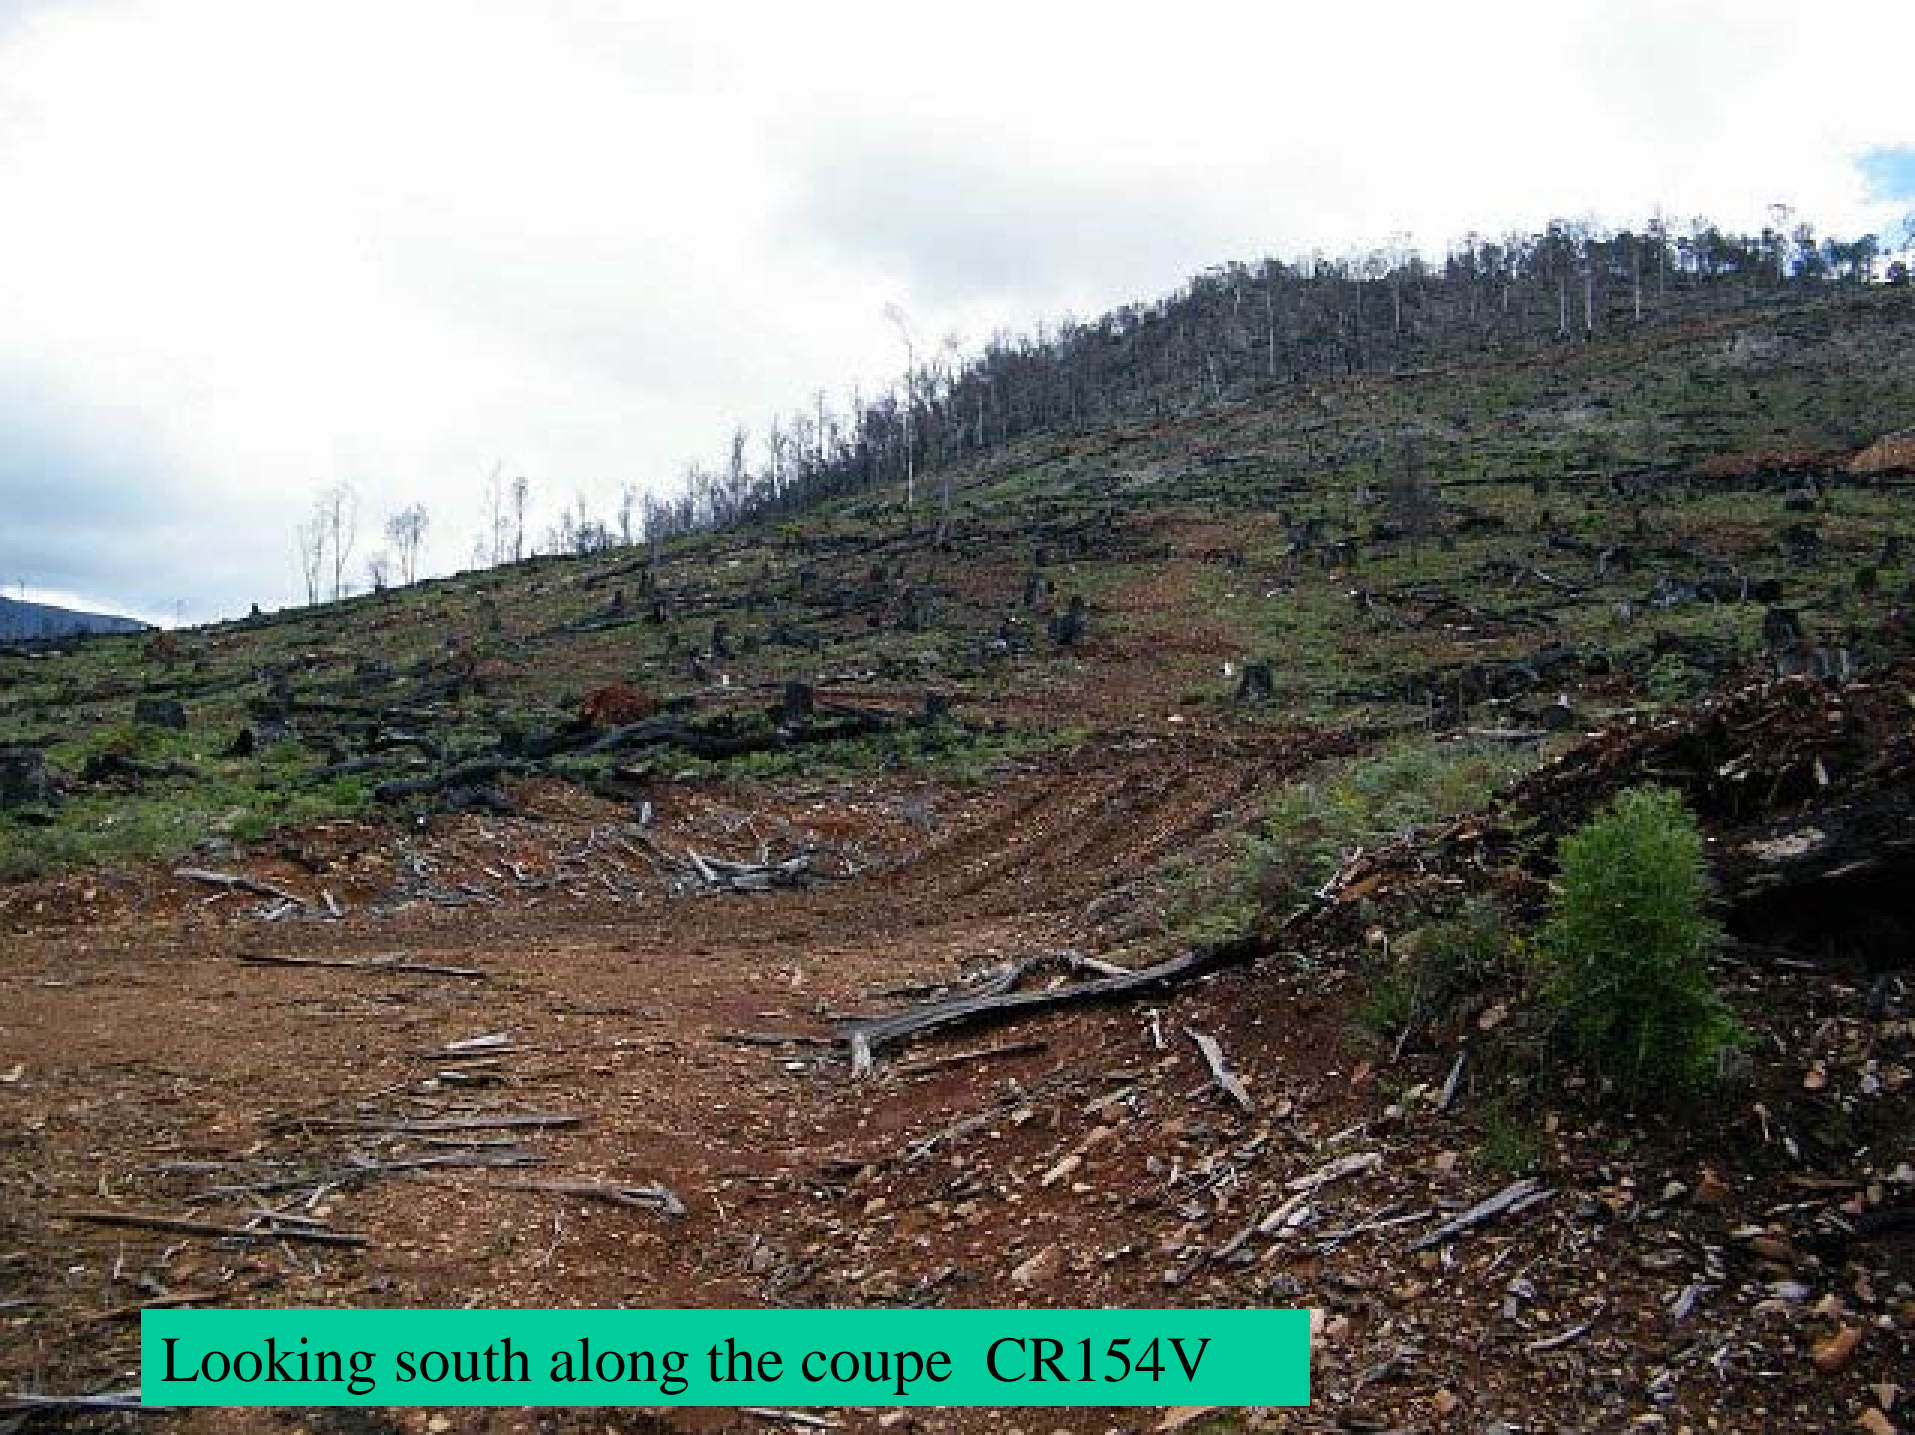
Looking south along the coupe CR154V

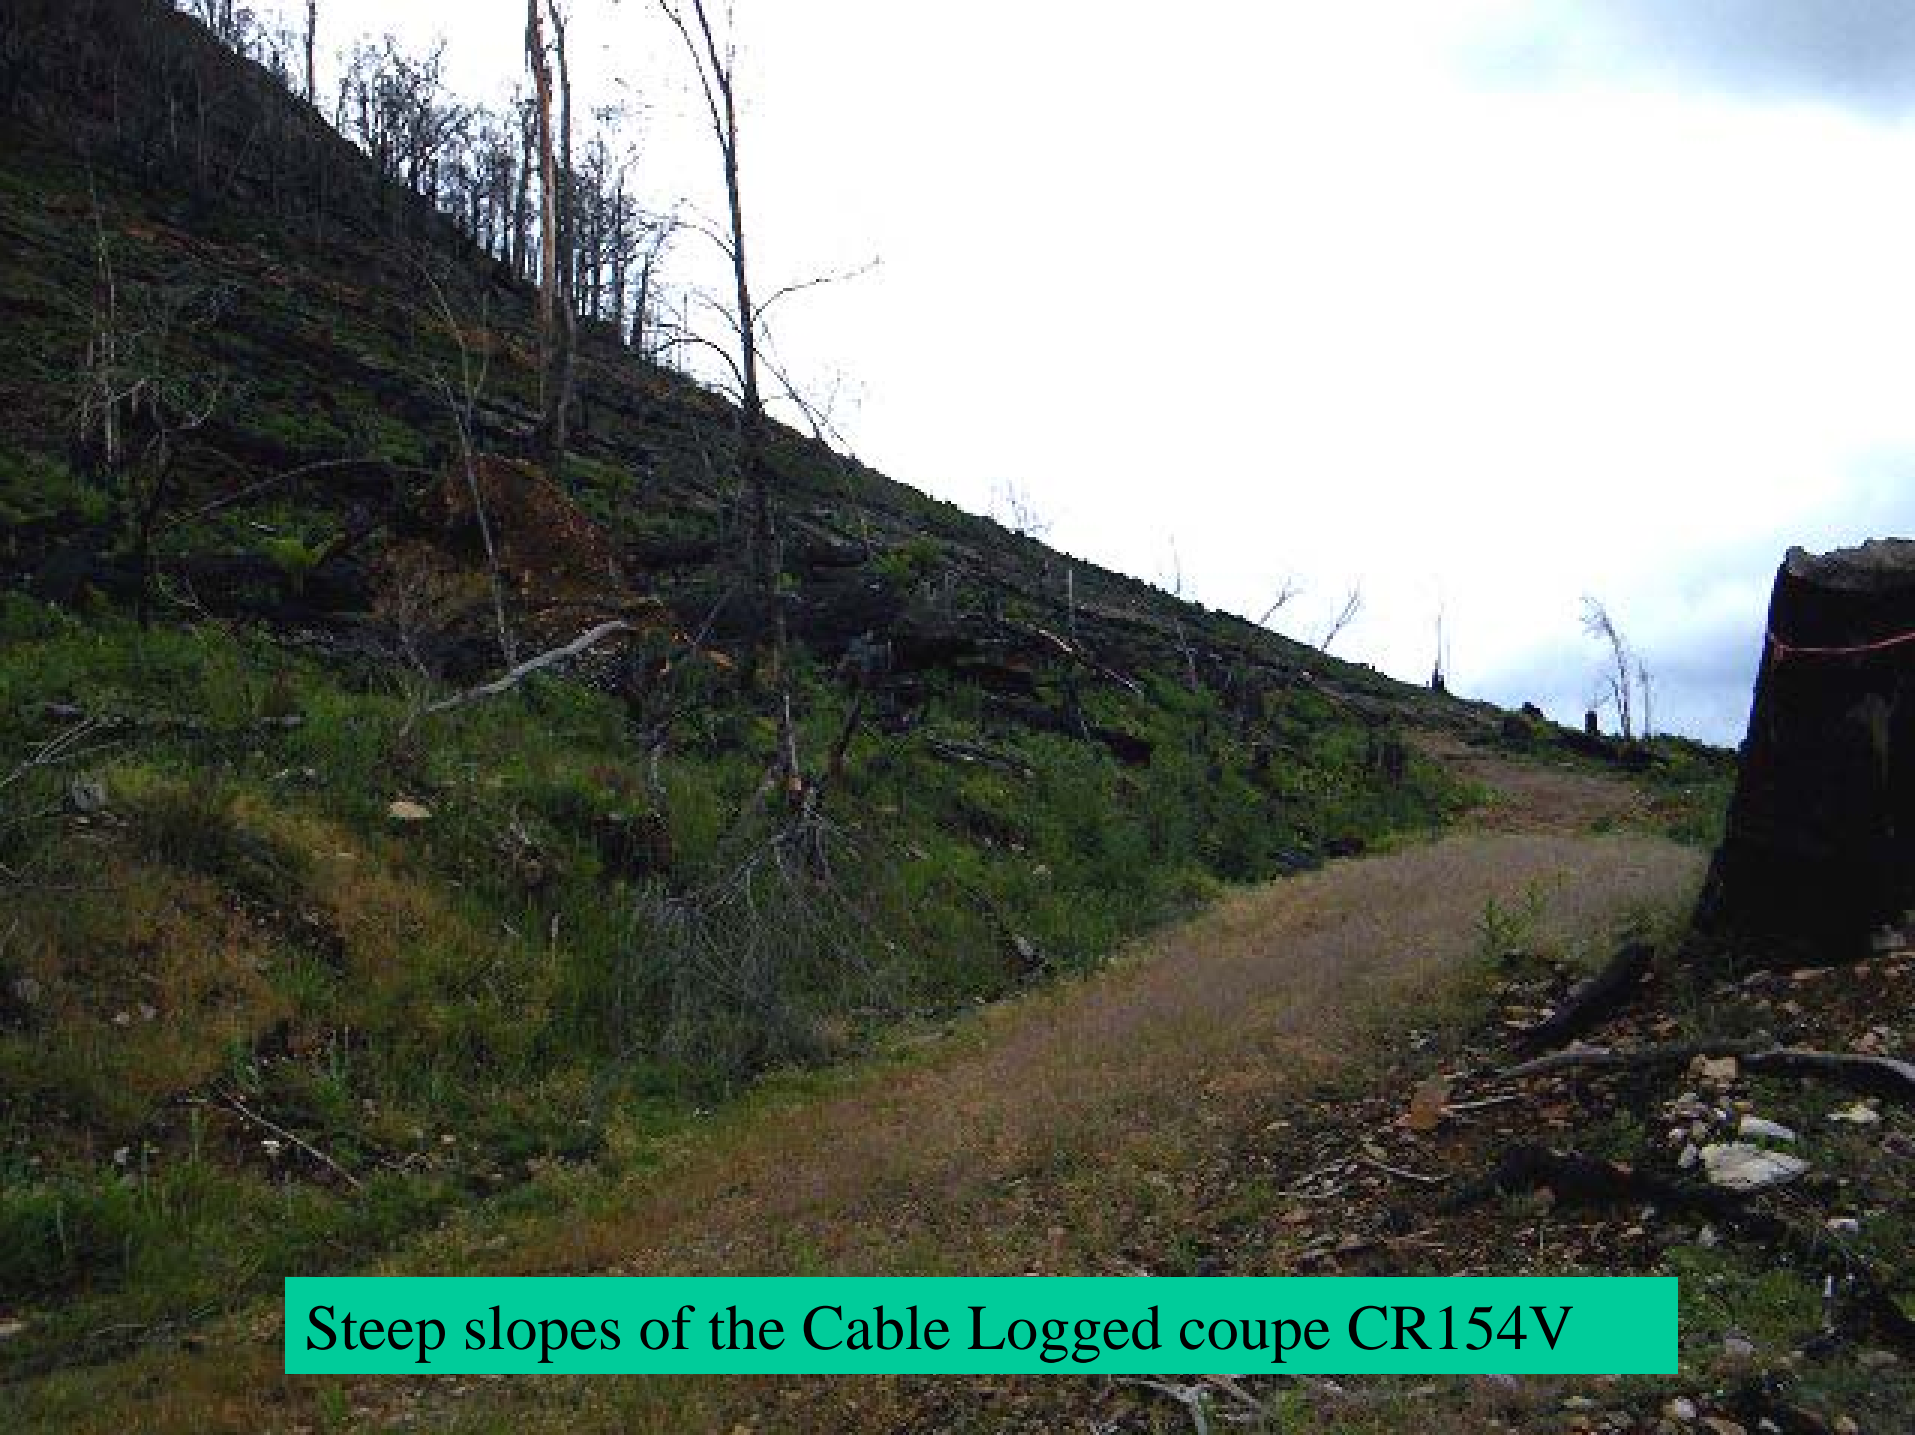
Steep slopes of the Cable Logged coupe CR154V

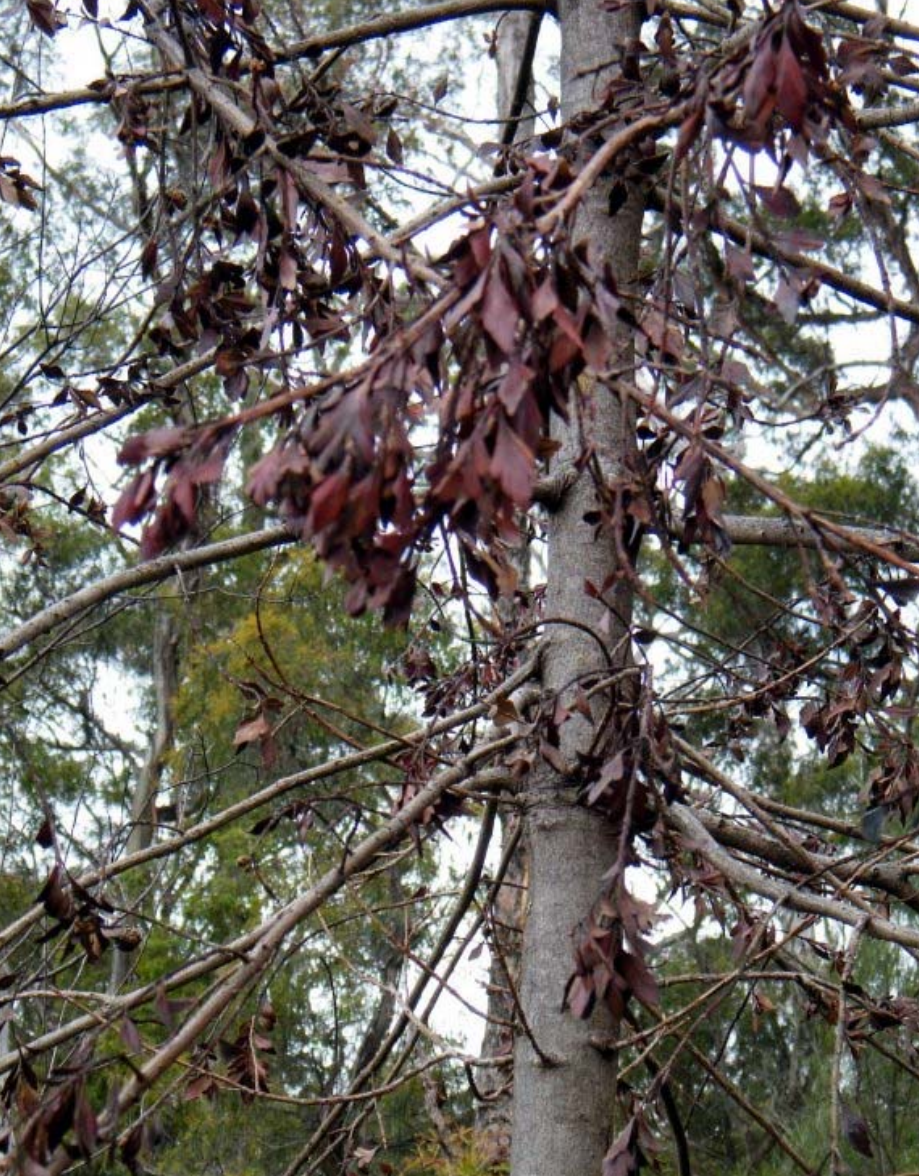
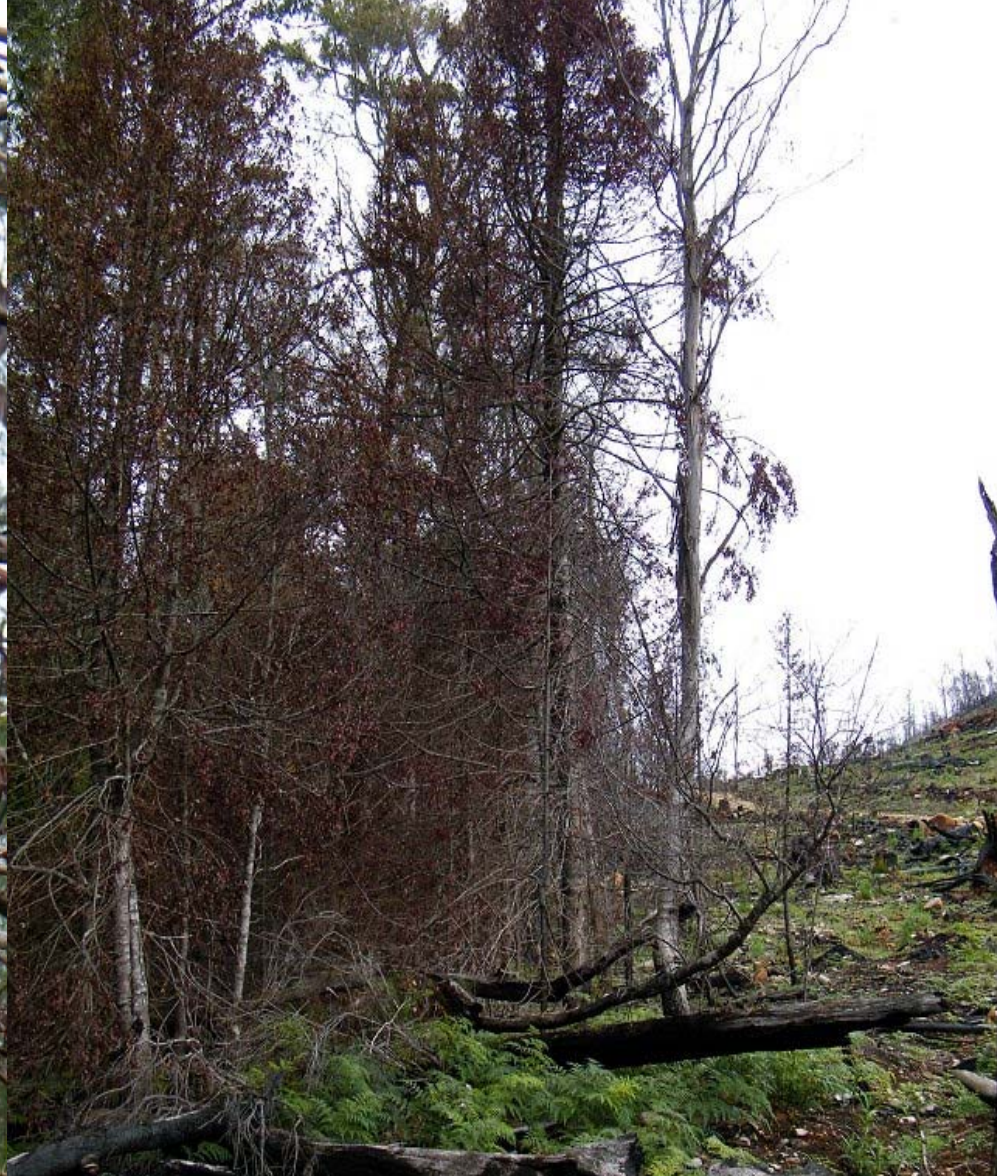
Not enough care in preparation meant that many celery top pines on the boundary were damaged by fire, What a waste of valuable resources

Celery top pines killed by the burnoff, CR154V

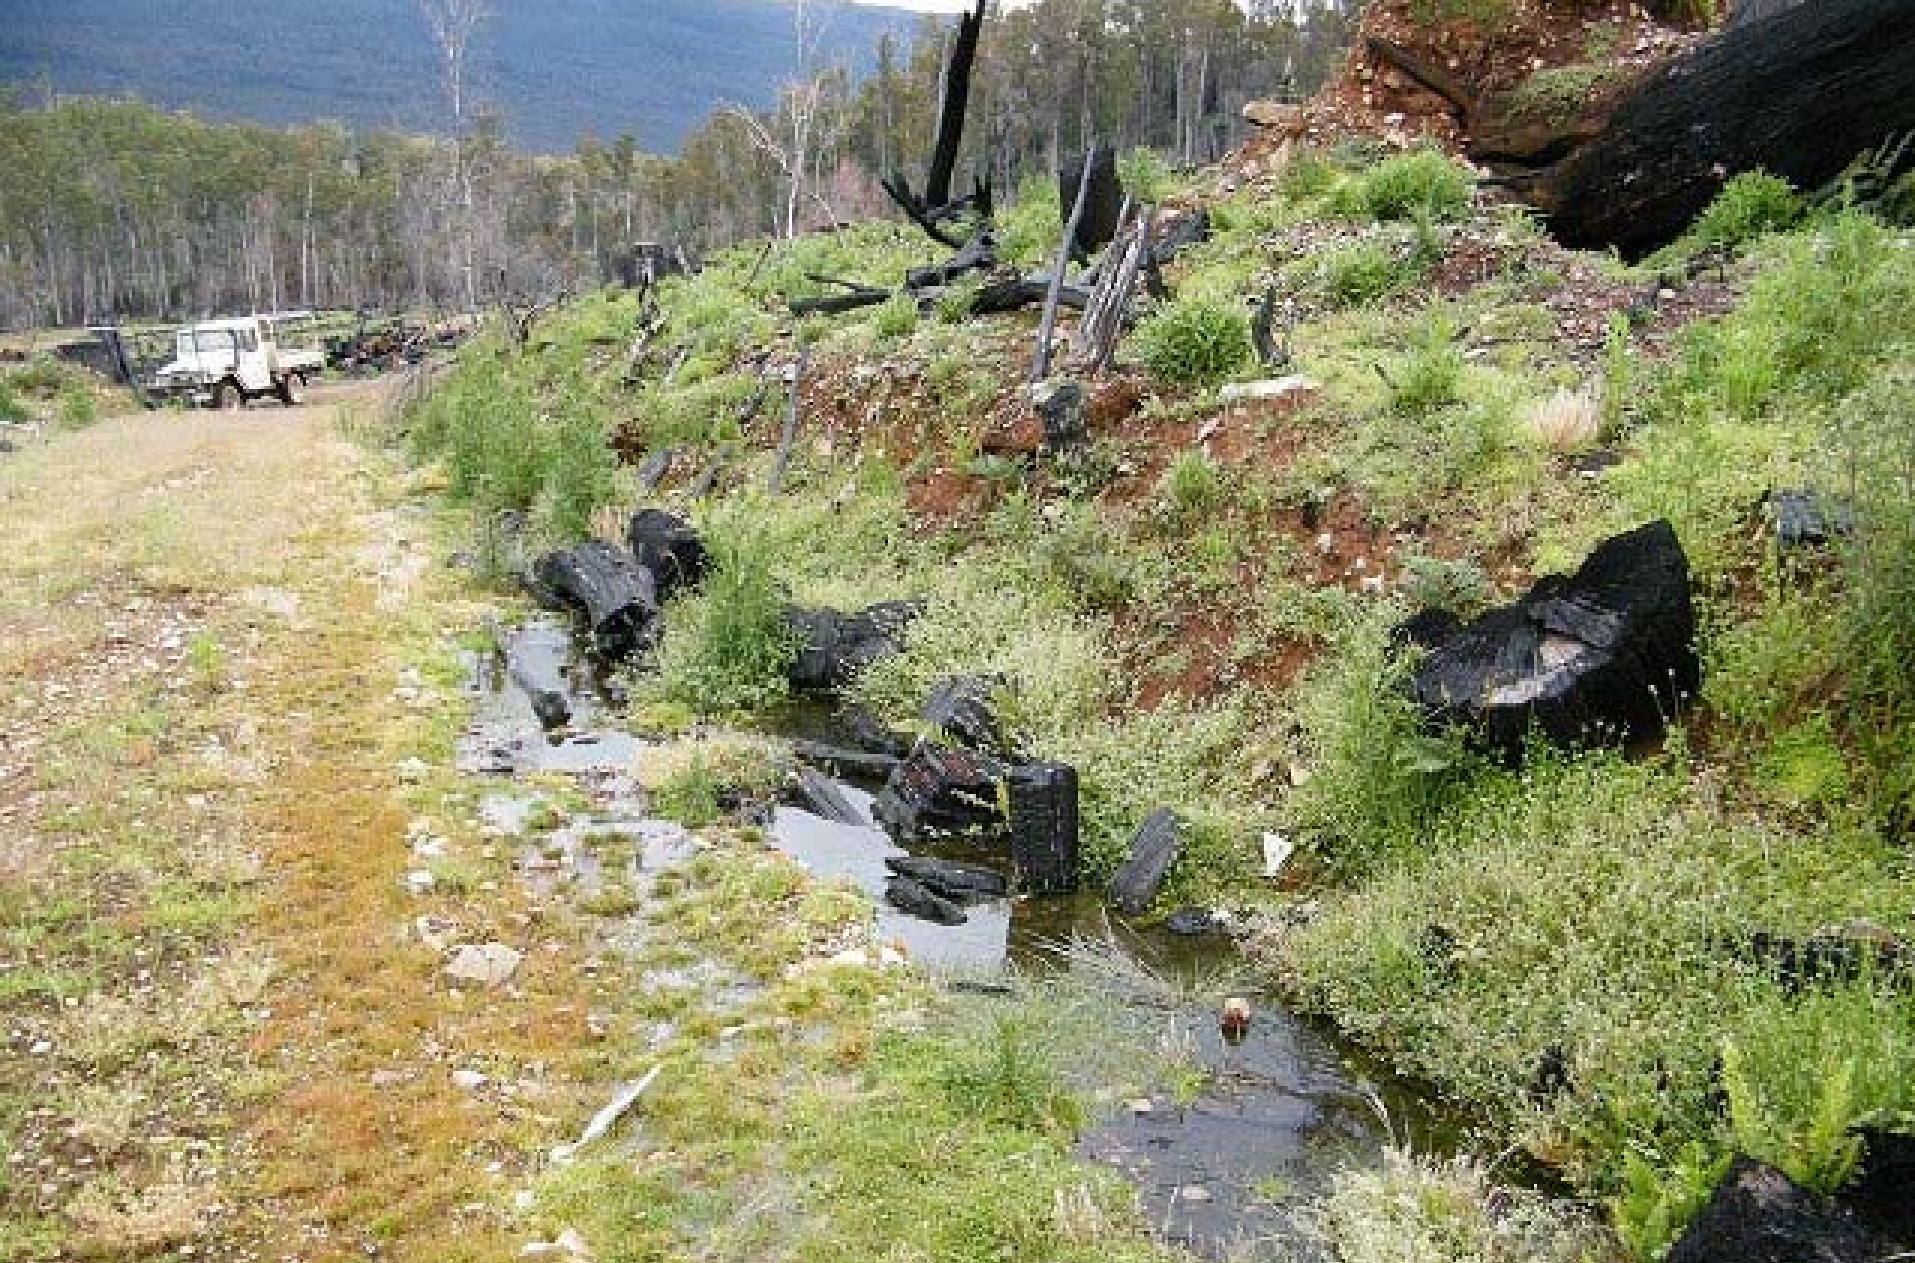
This track is channeling water away from it's natural path and causing erosion near the landing below

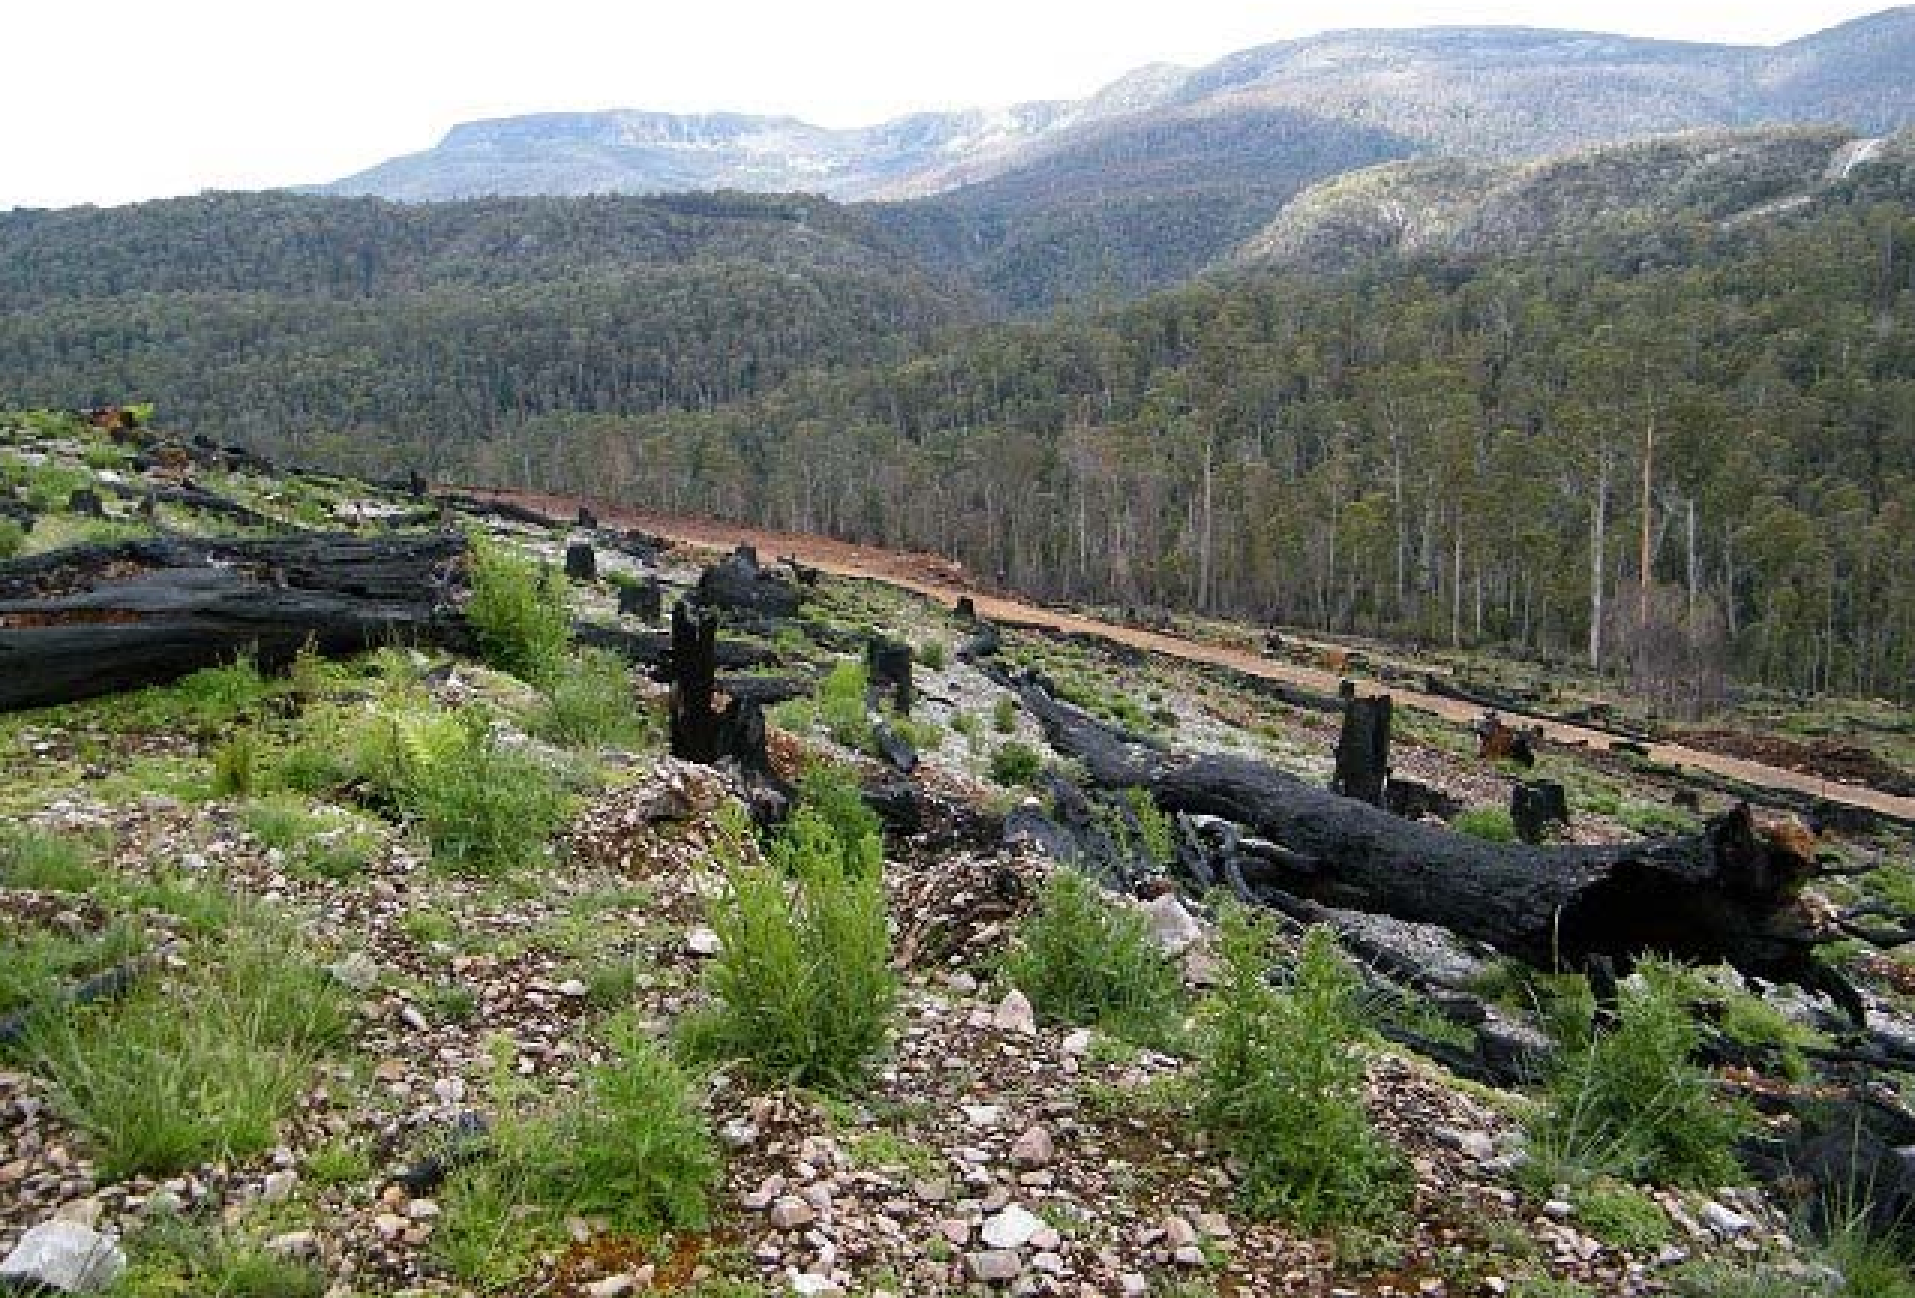
Where the fire jumped the fire trail, significant areas of surrounding forests were damaged

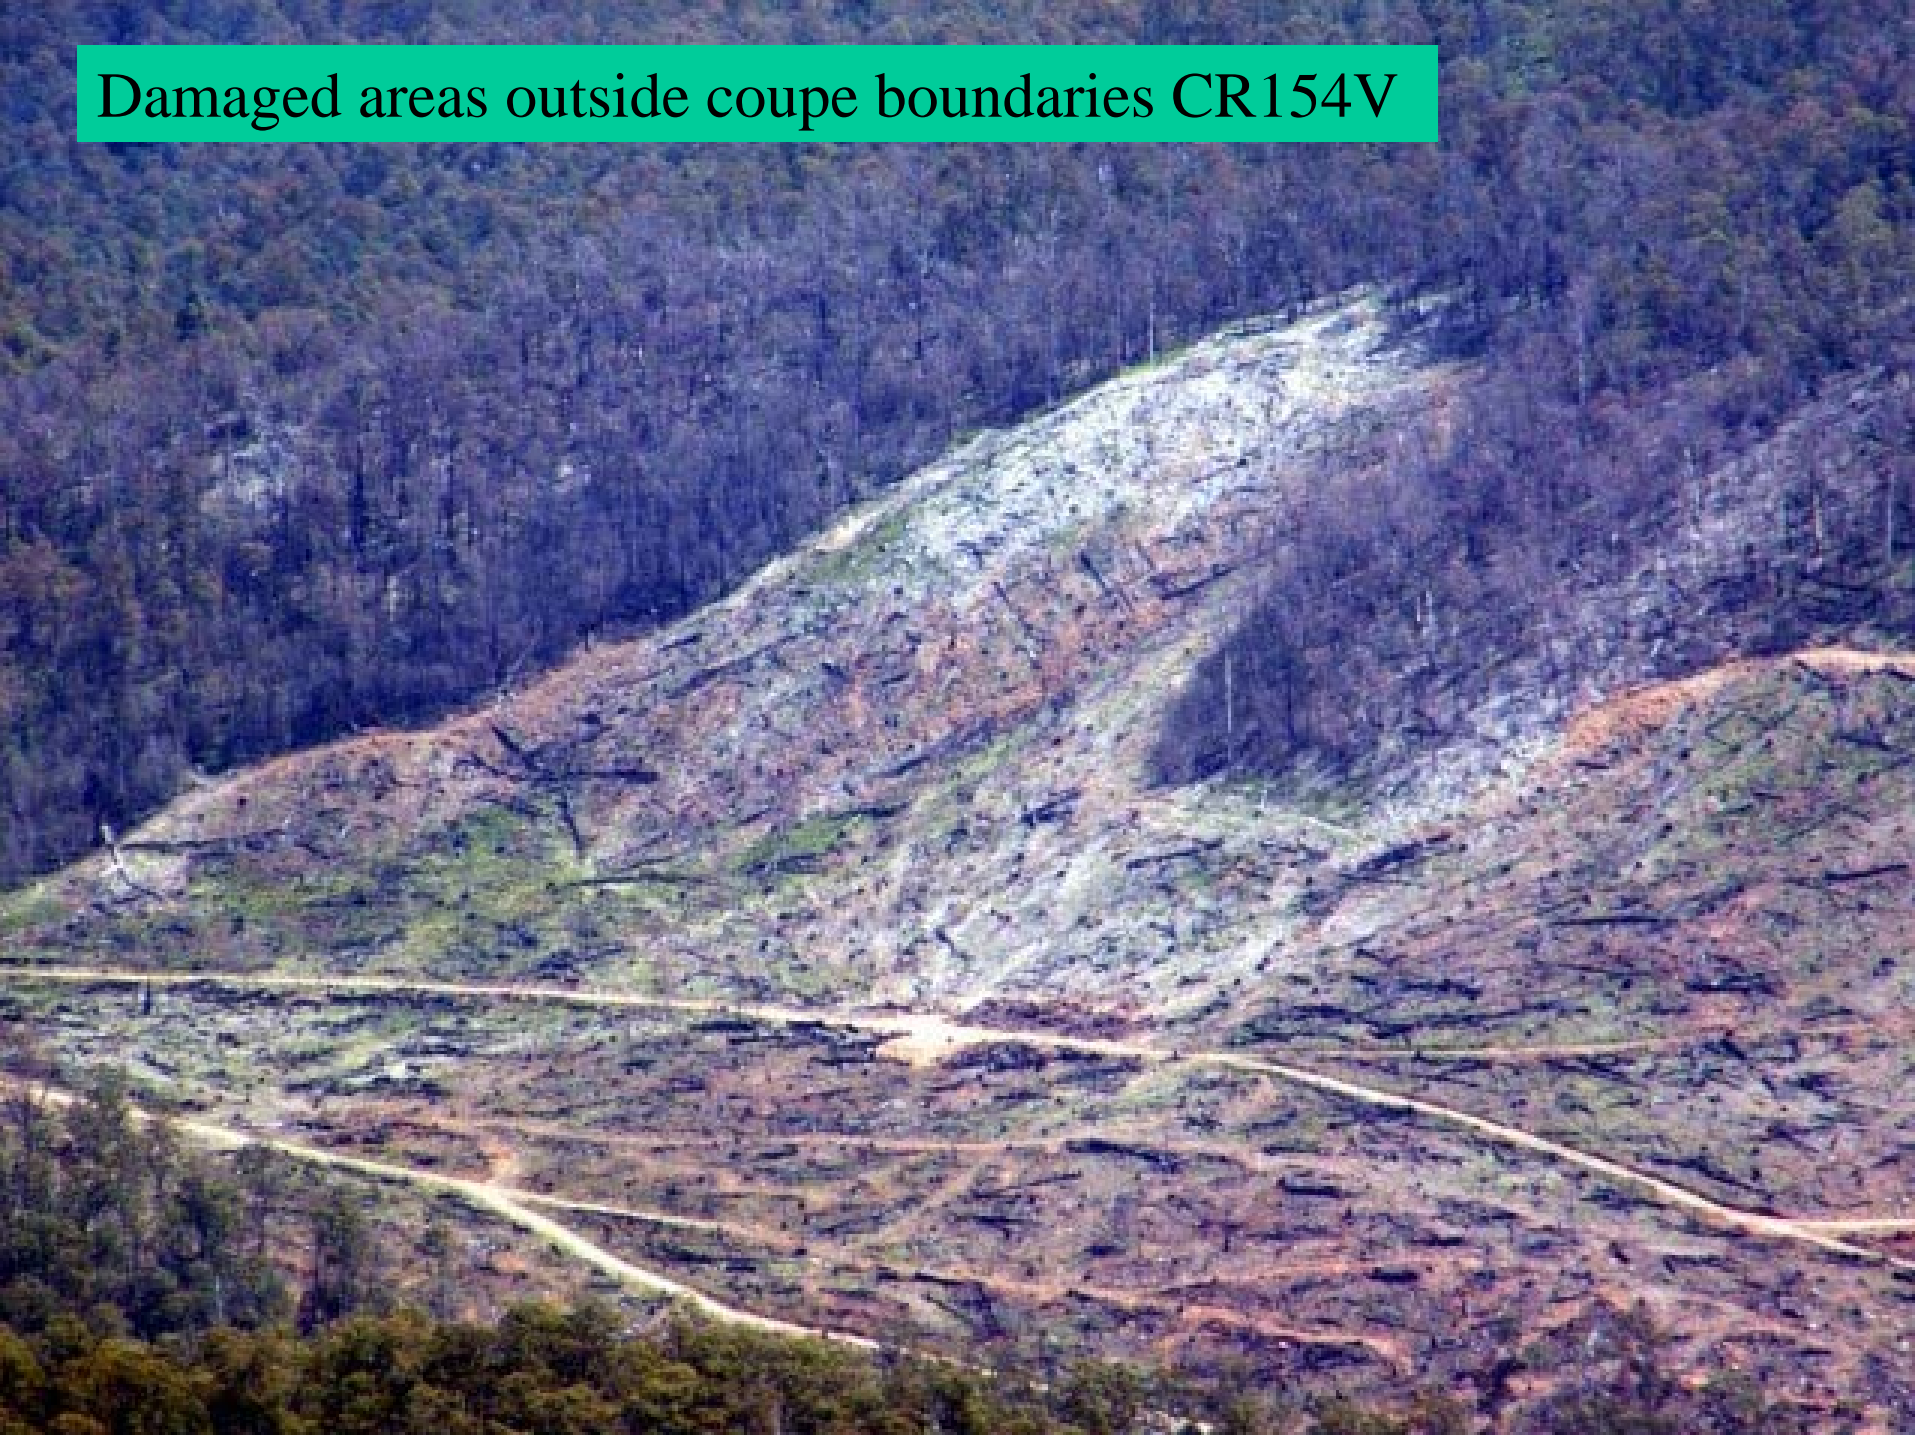
Little Fisher River Road Coupe FPP no JRM0010

- This coupe is surrounded by mixed forest. The eucalypts are mainly old and large with rainforest making up the rest of the forest.
- The coupe logged then a high intensity burn was conducted
- The burn damaged the streamside reserves and surrounding forest to a significant degree.

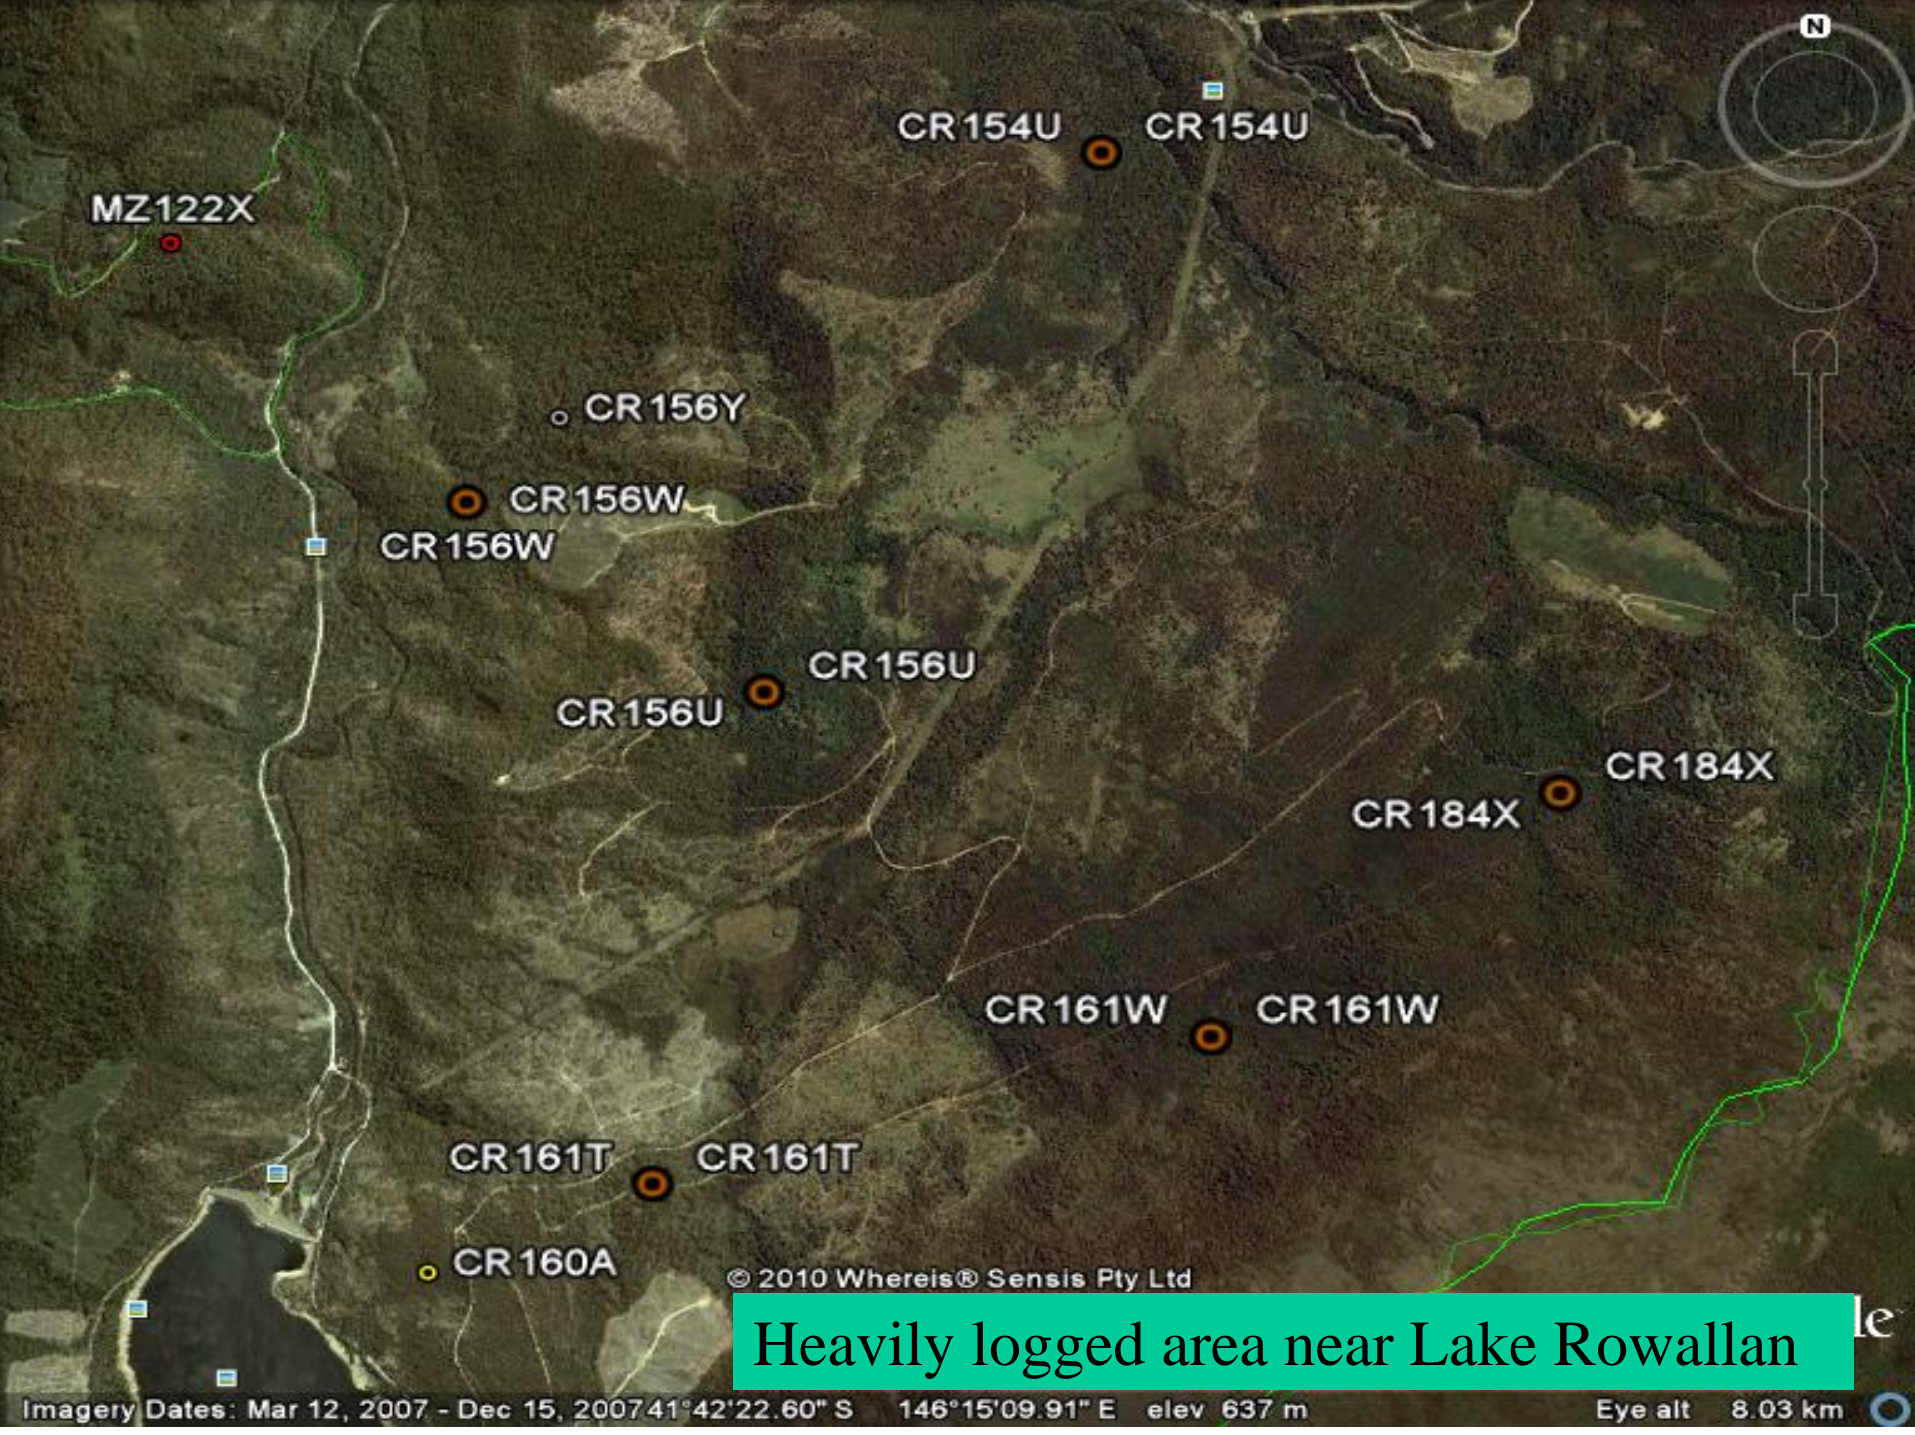
Heavily logged area near Lake Rowallan

Wet areas should not have been burnt or logged

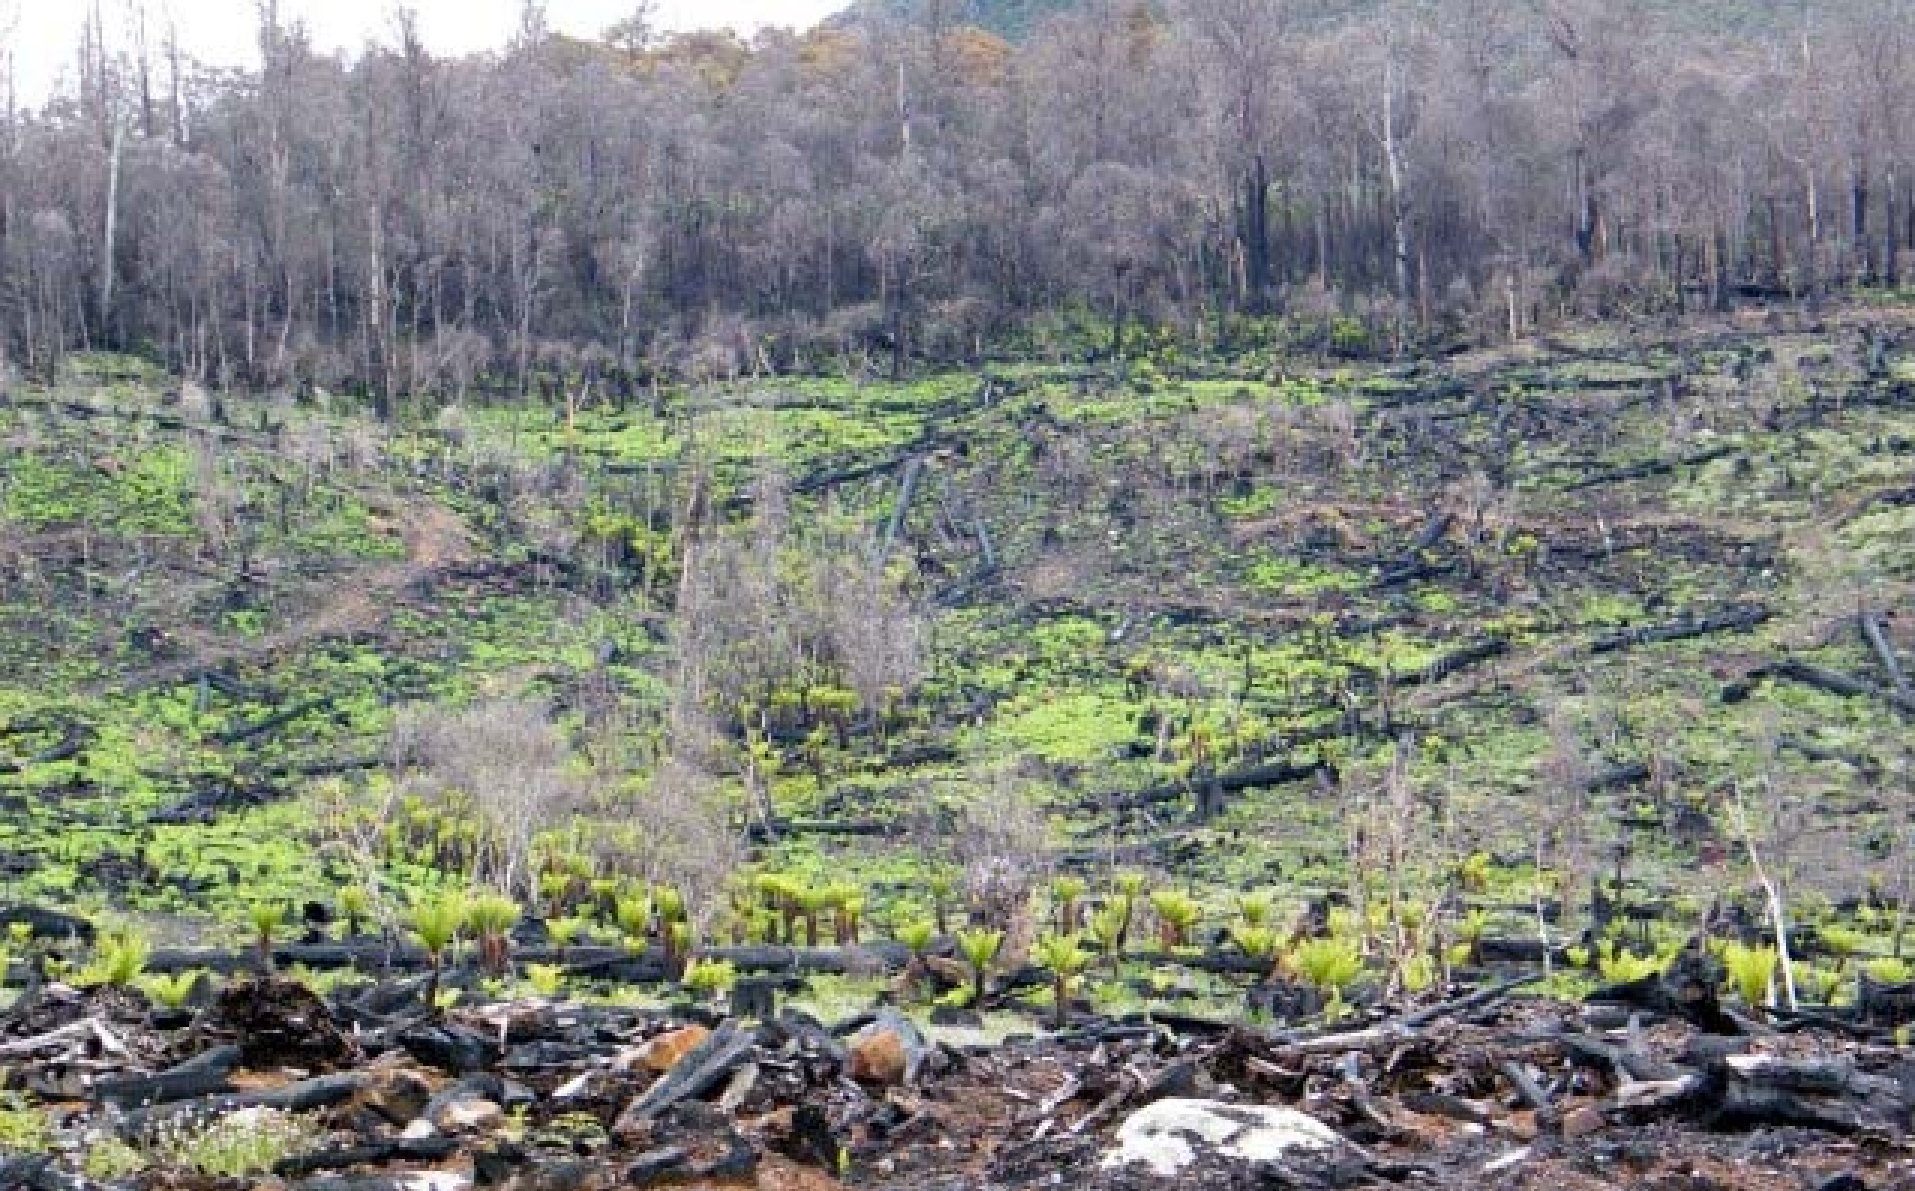
Streamside reserves trashed and burnt plus damage to surrounding forest from the high intensity burn
