The pictures that follow in this show were taken on the 19th December 2010.

The coupes are in the Little Fisher and Fisher River area near the Dublin Plains.

Coupe CR154V

The second series are from an unknown operator Forest Practices Plan JRM0010.

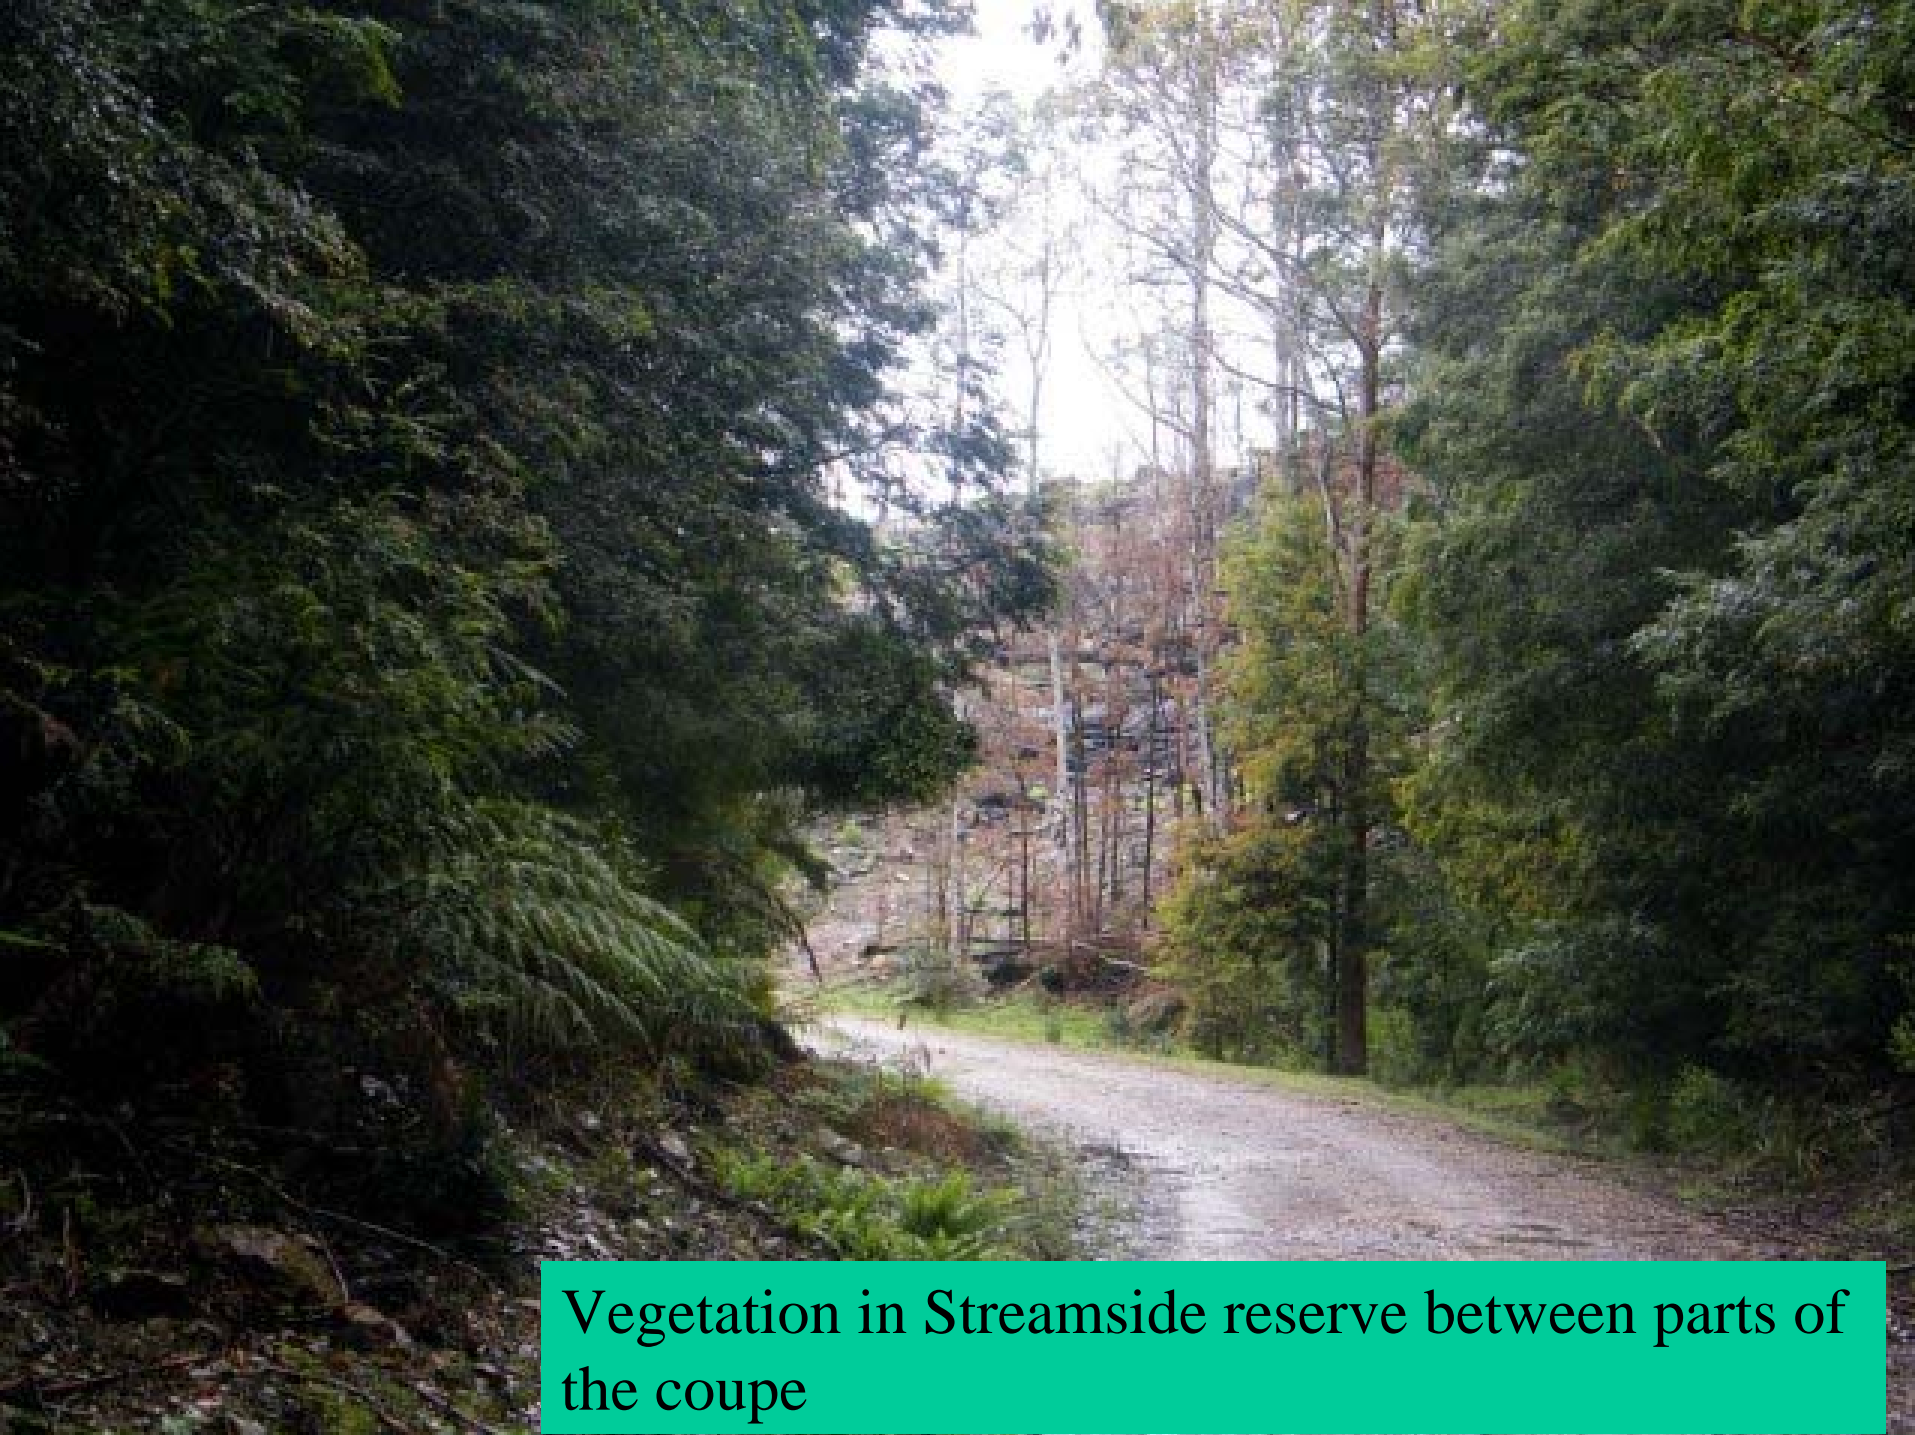
Vegetation in Streamside reserve between parts of the coupe

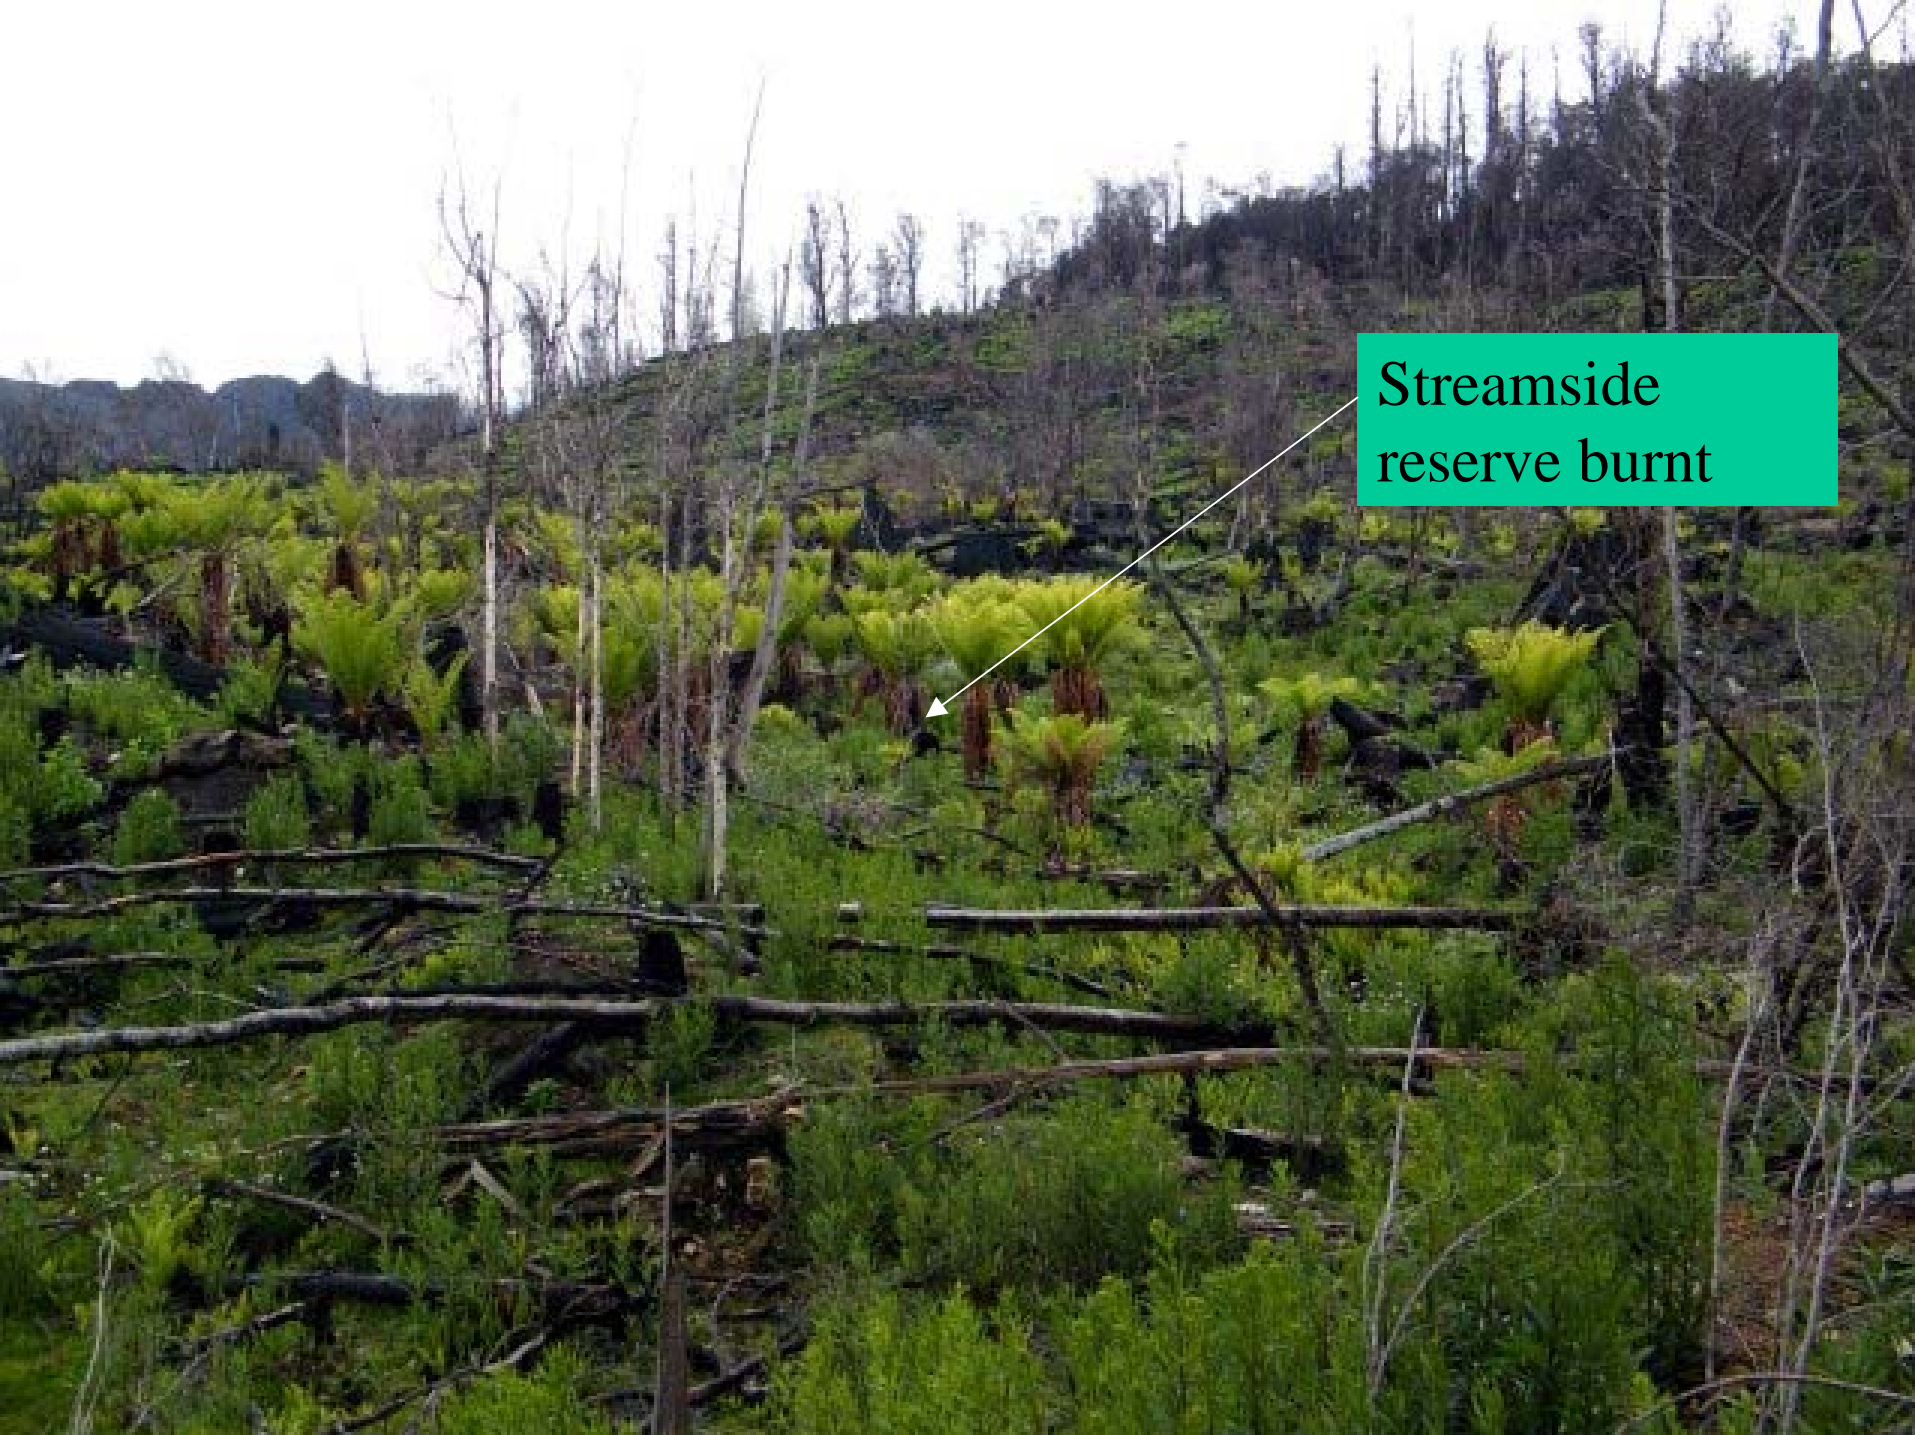
Streamside
reserve burnt

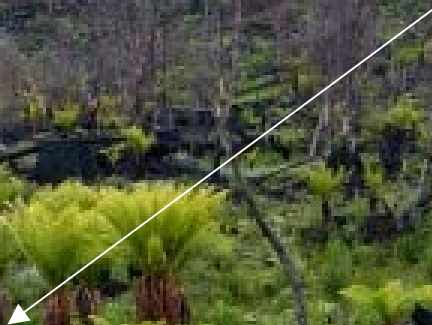
Steep slope in coupe JRM0010 Problems with sheet erosion likely

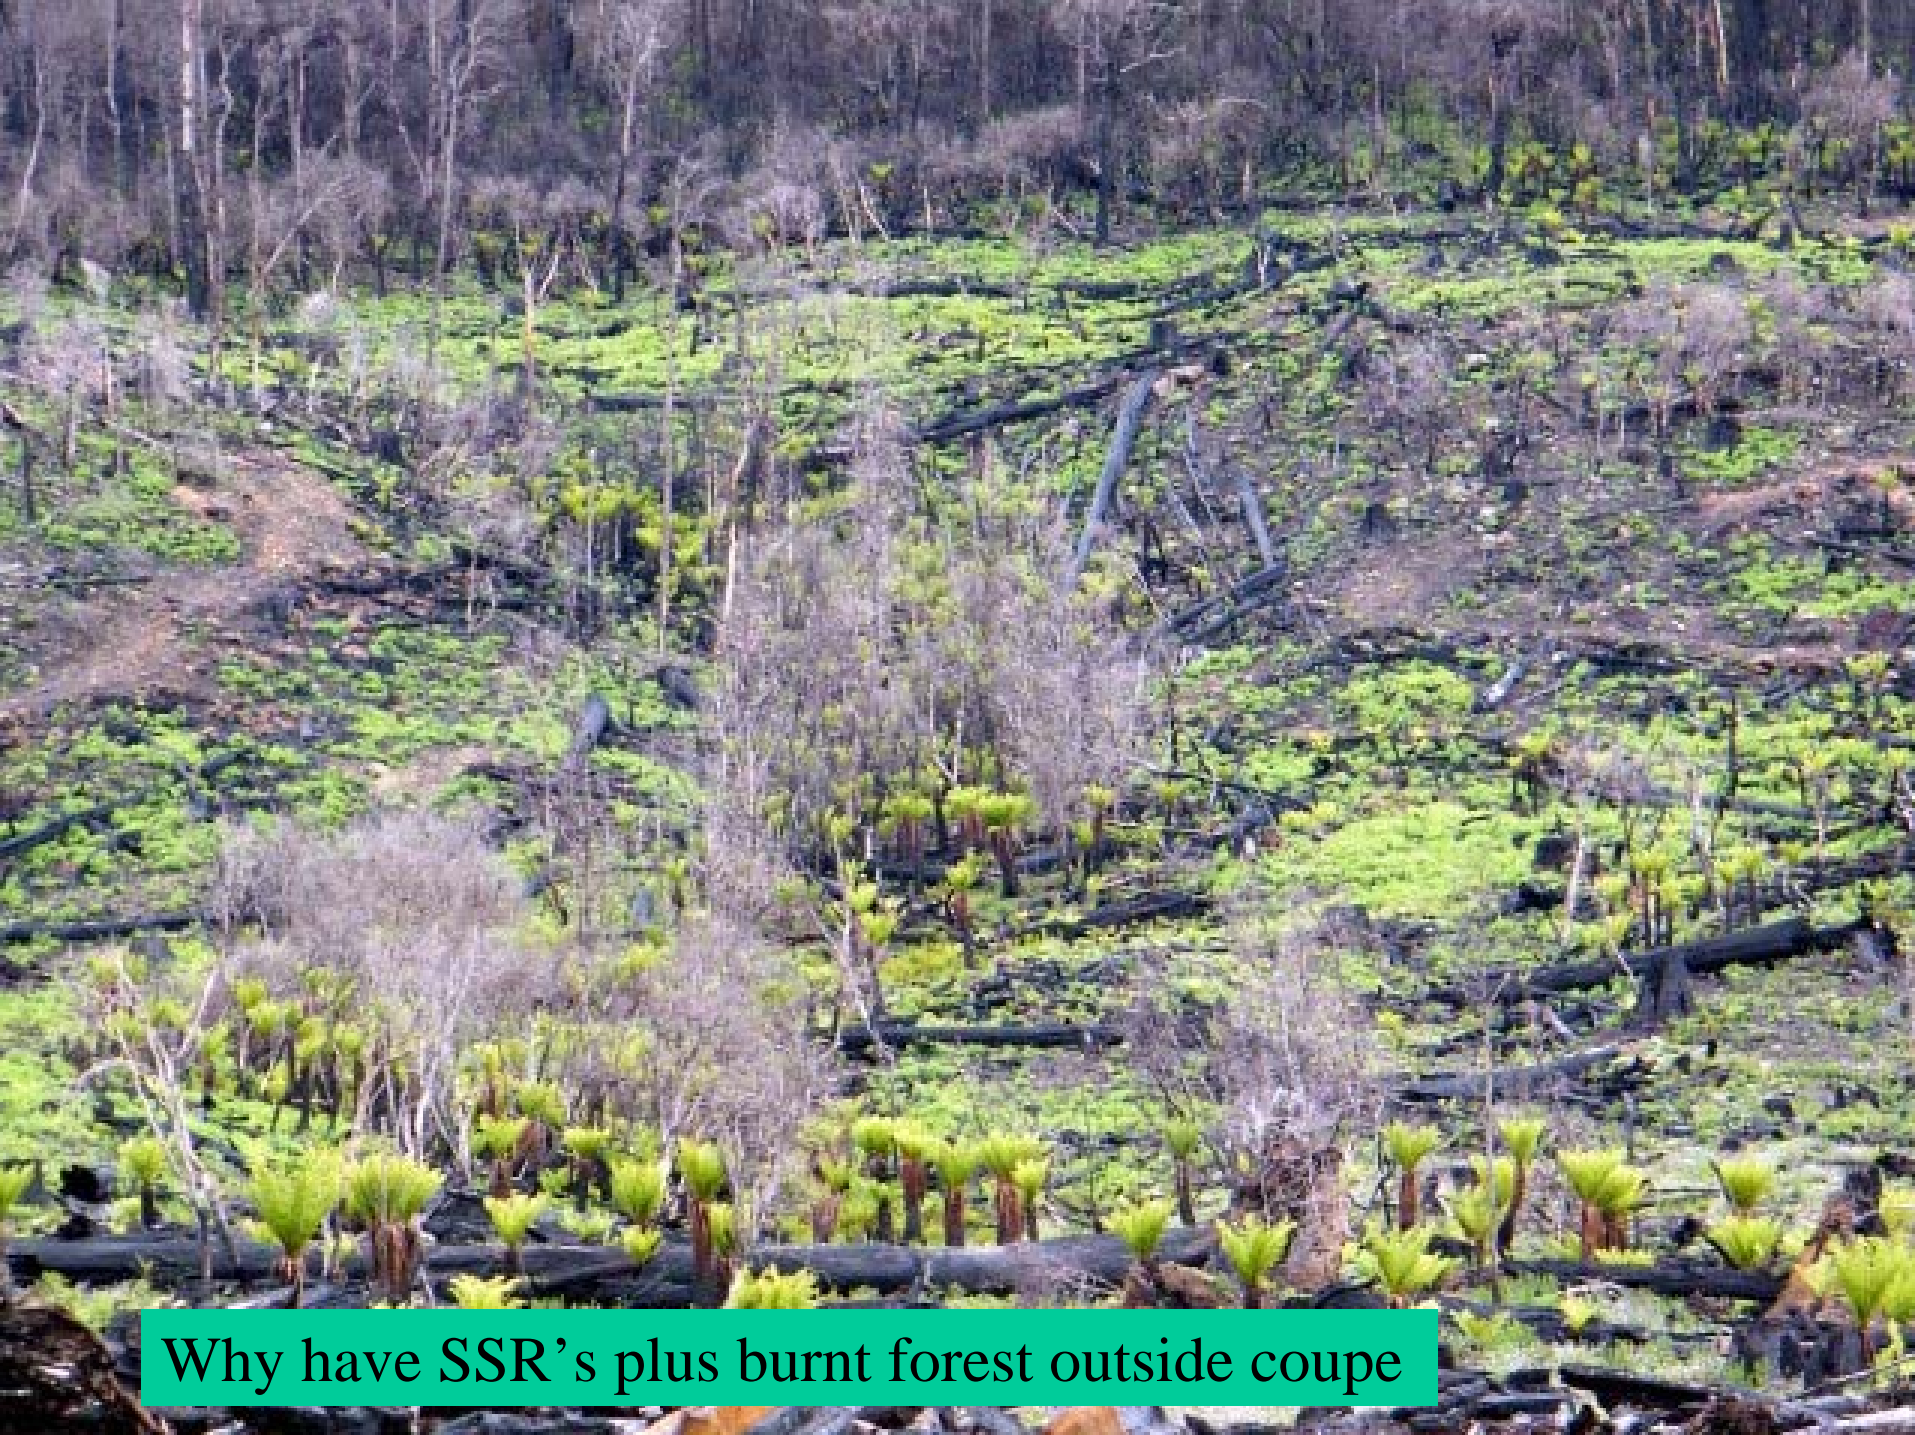
Why have SSR's plus burnt forest outside coupe

Note regrowth in foreground this area has been very heavily logged

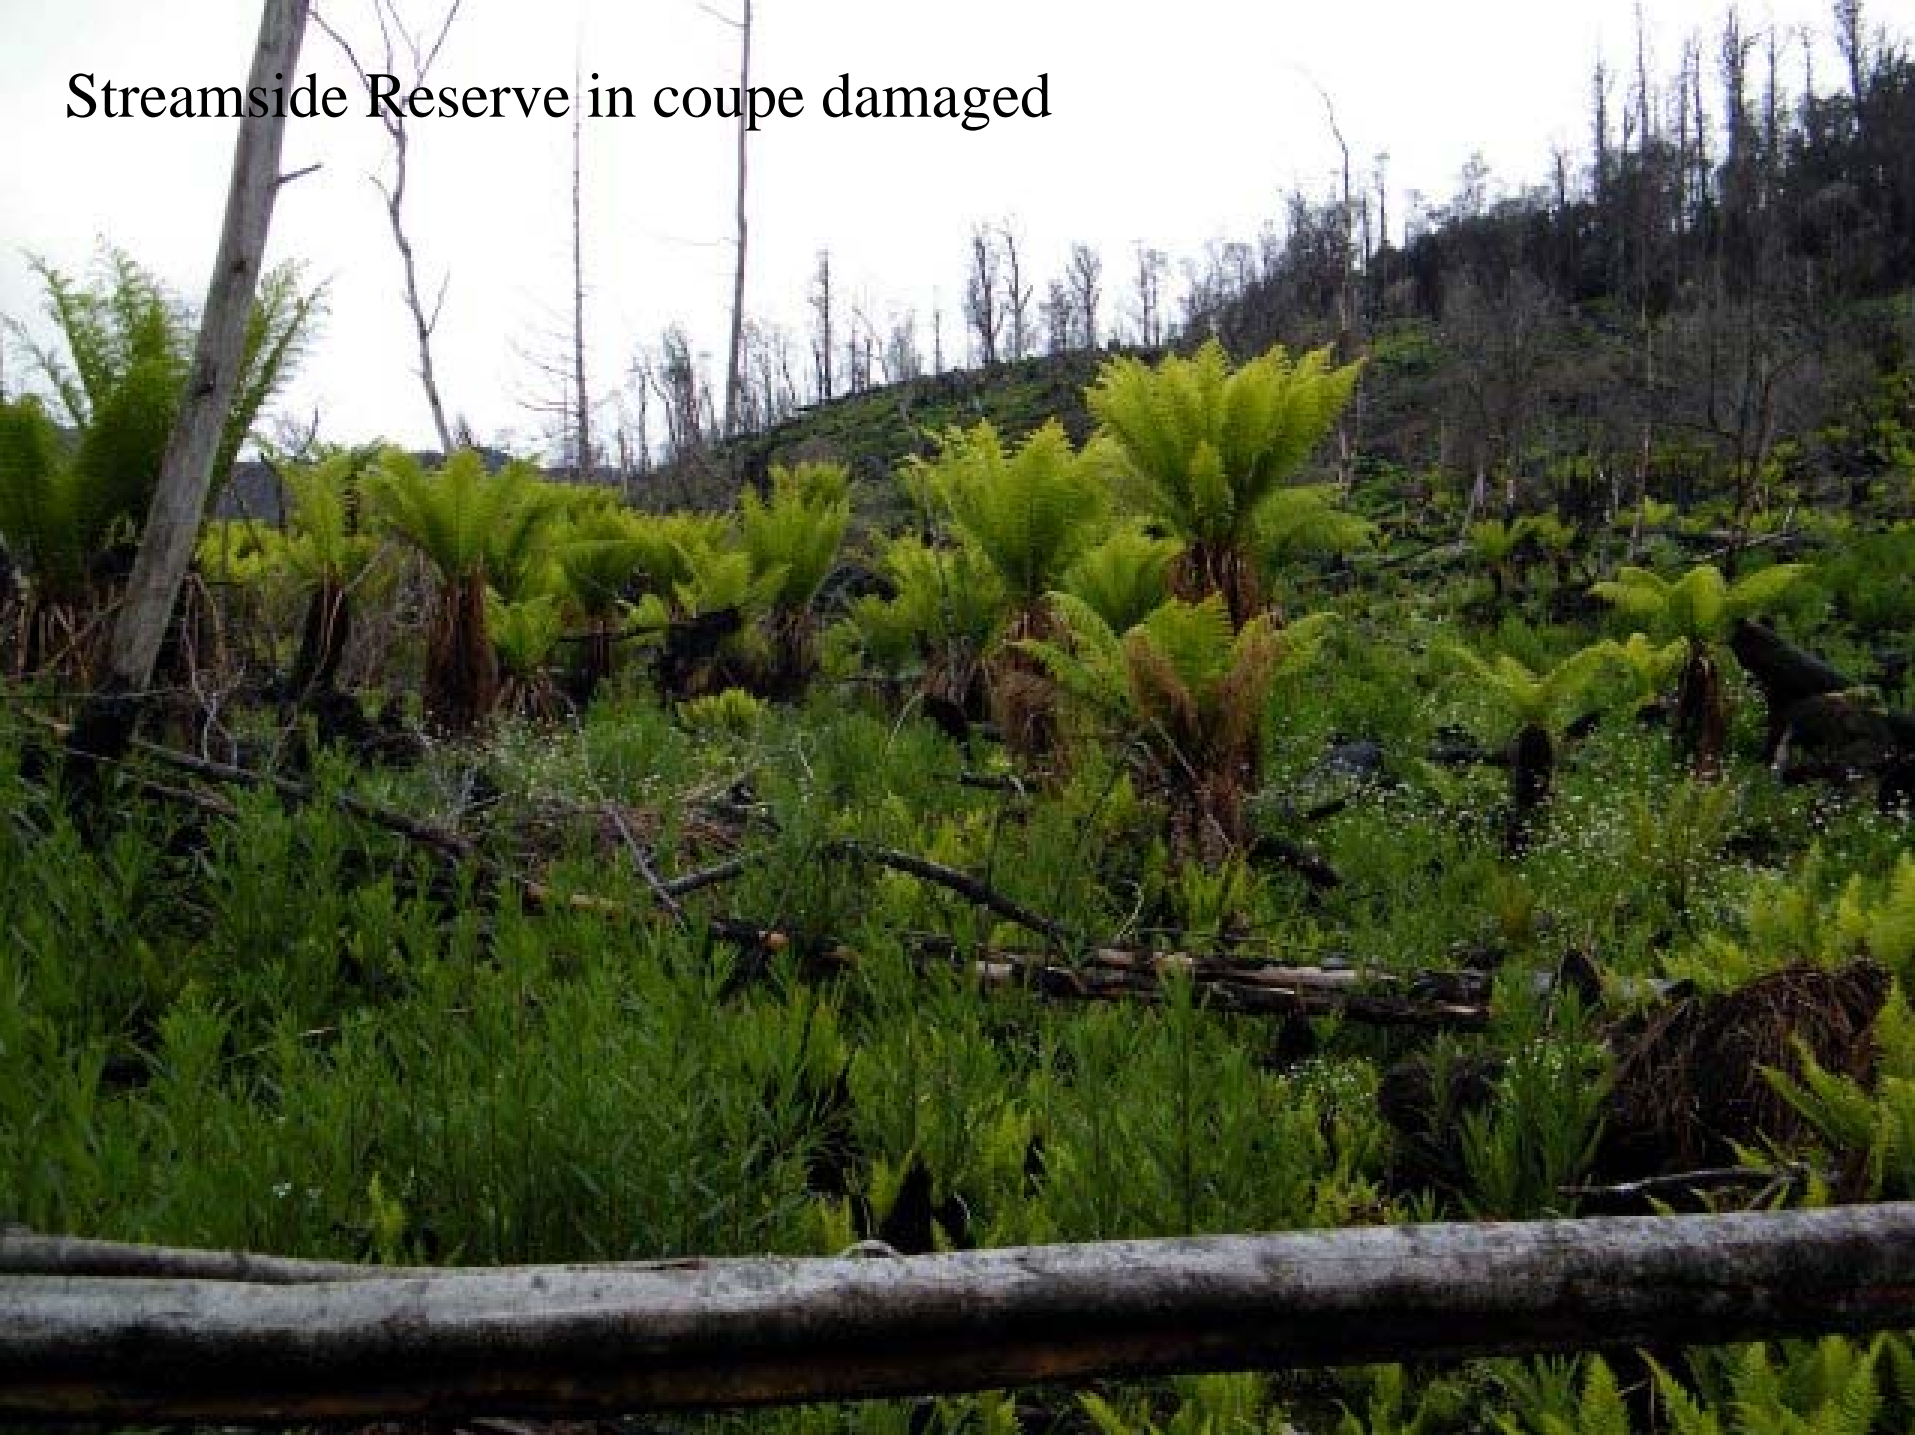
Trees removed from within Streamside Reserve
