Review of Harvey et al (2015) Project 1094-15

Expert Panel Report – Review of Harvey et al (2015)

WaterRA Project No. 1094-15 – Review of Harvey et al (2015)

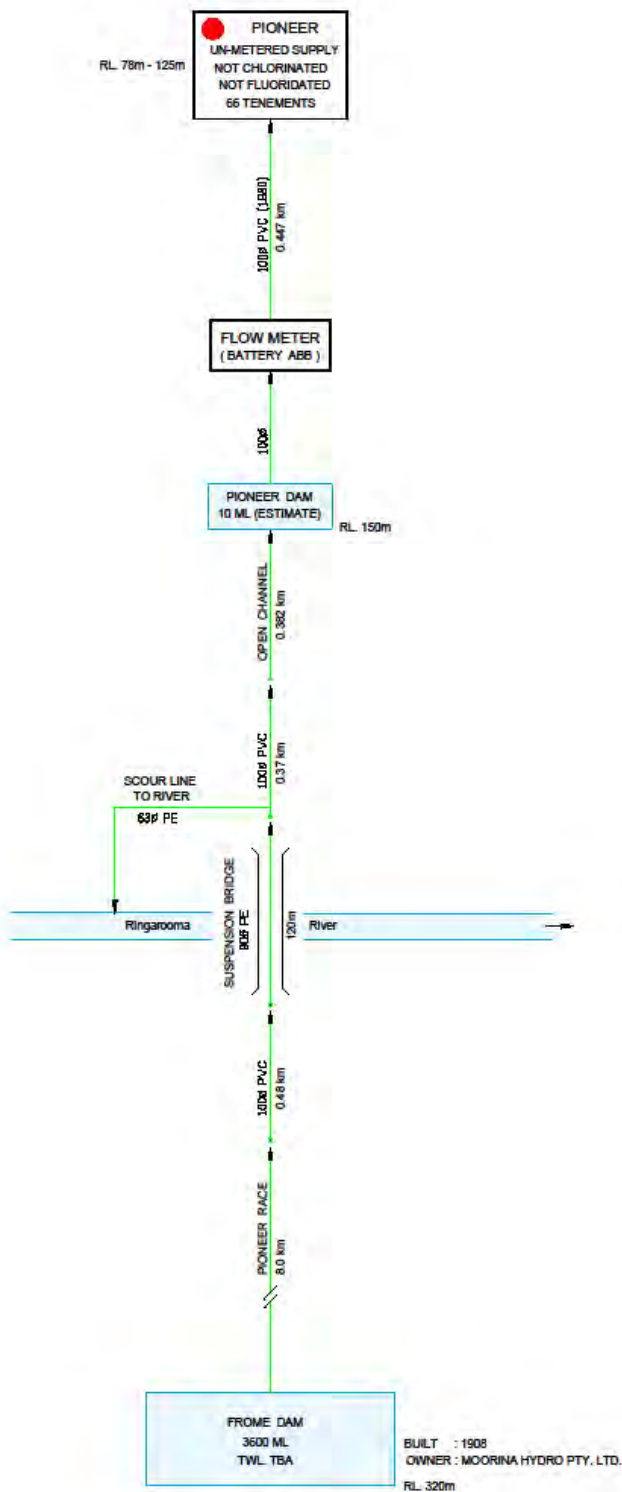
Figure 1 Pioneer Water Scheme in 2010

A schematic diagram of the Pioneer Water Scheme dated 2010, provided by TasWater, is given in Figure 1. The diagram shows that at that time water was supplied to the Pioneer Dam from the Frome Dam via an open raceway and a series of 100mm diameter polyvinyl chloride (PVC) pipes. Water was then transported from the Pioneer Dam via another length of 100mm diameter PVC pipe into a mixture of PVC and polyethylene (PE) pipes, which form the basis of the town's distribution system. Detailed plans of the distribution system within the township indicate that it consists largely of 50mm diameter PVC pipes laid in about 1980, plus further additions of 40mm diameter PE pipes.

Information from TasWater states that, since around 2009, the water supply to Pioneer is no longer sourced from Frome Dam or the raceway infrastructure immediately below it. About 900 metres of the old water race downstream of the dam are no longer used and, since the construction of an irrigation project, it has not been possible to transfer water from the Frome River along that part of the water race. This change also applies to the infrastructure associated with the old Moorina Power Station. Since this change, water for the Pioneer Dam is sourced from the open Pioneer water raceway immediately above the dam, which collects surface water runoff and water from a small water course intercepted by the raceway somewhere between the site of the old Moorina Power Station and the town of Pioneer (a distance of 5 kilometres).

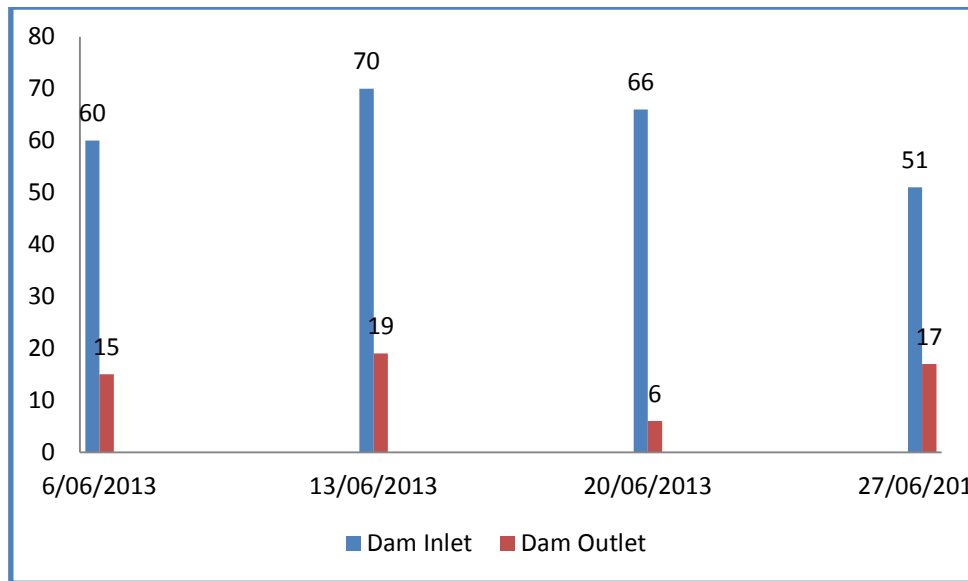
Figure 1. True colour at the Pioneer Dam Inlet and Outlet in June 2013.

There does appear to be a definite reduction in colour between the Dam Inlet and the Dam Outlet in the June 2013 samples (Figure 1). The difference is significant ($P < 0.05$).

This suggests that the sediments may have a significant organic component which in turn might support a range of microorganisms. It is further likely that the redox status of these sediments may change.

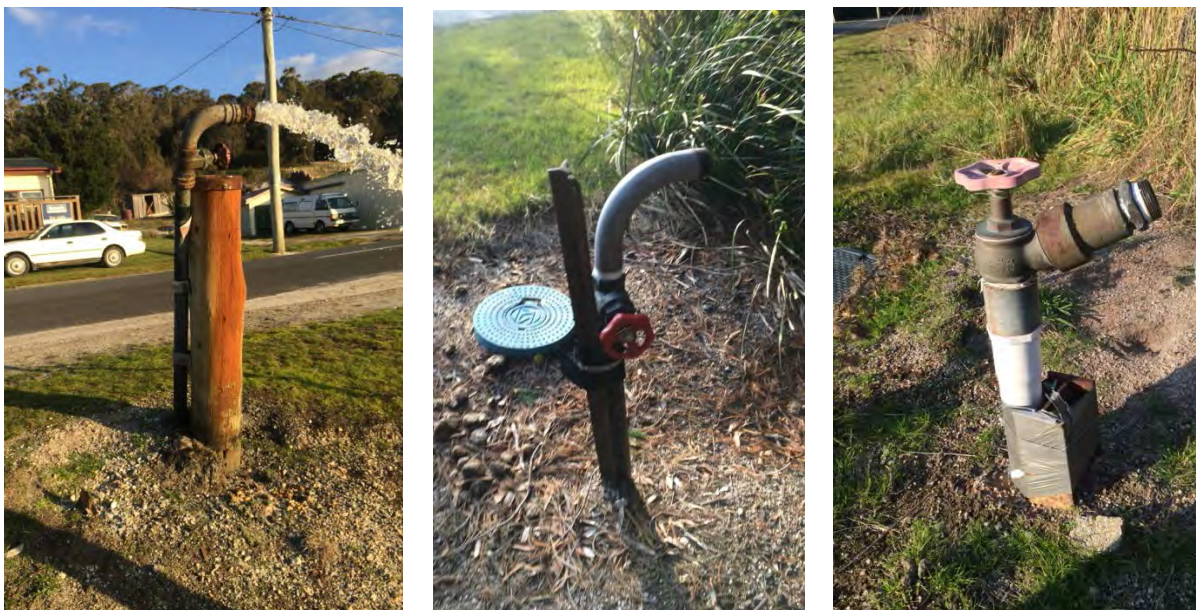
Figure 2. Pioneer town hydrants

During the site visit by the WaterRA panel, copper pipe was observed at the back of the toilet block. The pipe seemed to be pressure jointed rather than soldered. There were also new brass fittings on many of the town hydrants (Figure 2).
